LAKE MICHIGAN SHORELINE RECESSION AND BLUFF STABILITY IN SOUTHEASTERN WISCONSIN: 1995

TECHNICAL REPORT
NUMBER 36

**LAKE MICHIGAN SHORELINE RECESSION AND
BLUFF STABILITY IN SOUTHEASTERN WISCONSIN: 1995**

Southeastern Wisconsin Regional Planning Commission

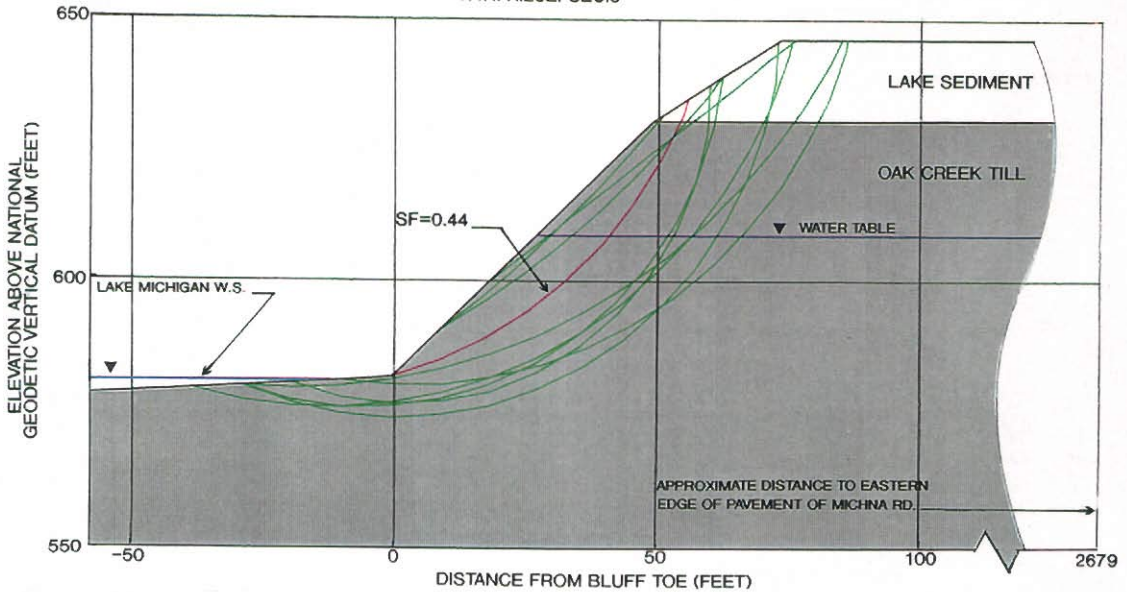
T.4N. R.23E. SEC.8

considered. The analytical results indicated a safety factor of less than 1.0 for 17, or 68 percent, of the 25 critical conditions, as represented by the set of most critical conditions determined in each of the 25 analyses considered. In addition, a safety factor of less than 1.0 was determined for 89, or 35.6 percent, of the 250 conditions analyzed. Given the analytical results and the 1995 field observations, the bluffs were considered marginally unstable with respect to rotational failure. The 1995 field observations indicated that shallow translational failures may occur. The 1977 study reported a bluff safety factor of 0.55.

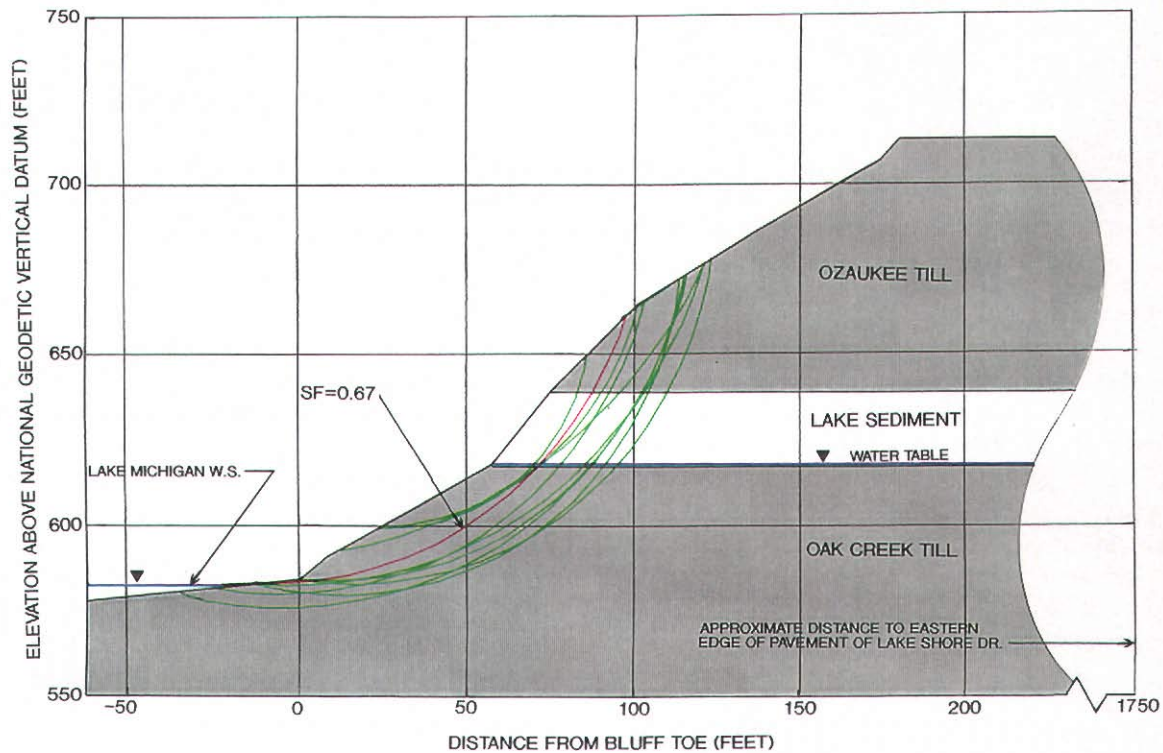
PROFILE 12-10
T.9N. R.22E. SEC.8

portion of the slope was less than 50 percent vegetated. The 1995 field observations indicated that the upper part of the slope shows a fresh scarp which was evidently the top of a large deep-seated slump lump.

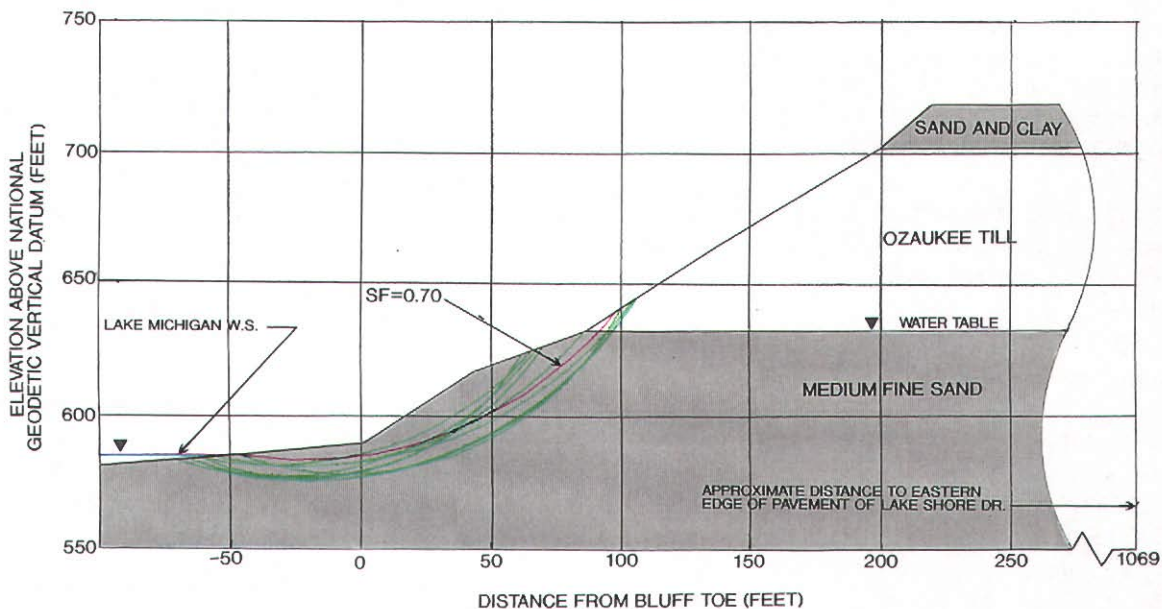
T.10N. R.22E. SEC.28

Reach 12 was characterized by Profile No. 12-23. Results of the slope stability analysis, shown in Figure 75, indicated that the bluff was unstable with respect to both rotational and translational failures in the zone, with a safety factor of 0.7. The 1977 study reported a bluff safety factor 0.96.
