LAKE MICHIGAN SHORELINE RECESSION AND BLUFF STABILITY IN SOUTHEASTERN WISCONSIN: 1995

TECHNICAL REPORT
NUMBER 36

**LAKE MICHIGAN SHORELINE RECESSION AND
BLUFF STABILITY IN SOUTHEASTERN WISCONSIN: 1995**

Southeastern Wisconsin Regional Planning Commission

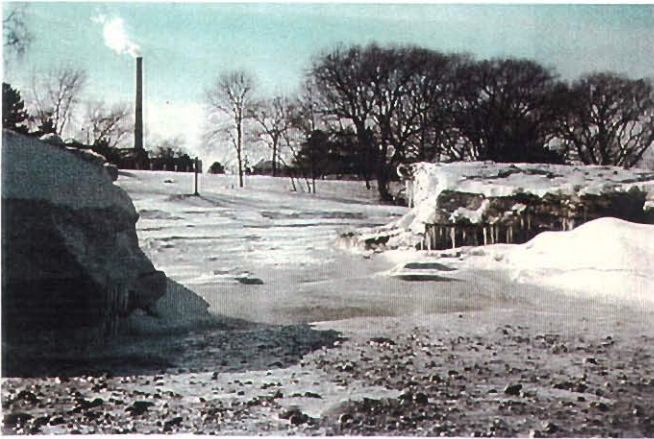
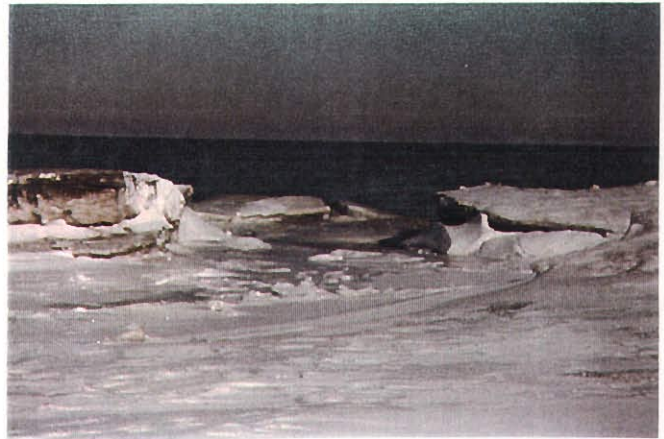
Figure 9

Another phenomenon associated with Lake Michigan which impacted the shoreline in analysis Section 30 in the vicinity of the Pike River estuary was the damming of the mouth of the Pike River by littoral drift in Lake Michigan. During storms on Lake Michigan, when onshore winds prevail, littoral drift rates increase landward of the surf zone and the mouth of the River can be dammed by the formation of a foreshore berm. Berms as high as six feet above the normal water level of the Pike River have been observed following severe northeasterly storms on the Lake. Subsequent to berm formation, the water level in the Pike River estuary begins to rise and continues to do so until the berm is breached. The River starts to flow over the crest of the berm, at which time rapid scouring of the sand and gravel deposits occurs with attendant rapid declines in water levels in the estuary. Photographs of such a breached berm about six feet tall are presented in Figure 9.

PHOTOGRAPHS OF A BREACHED BERM AT THE MOUTH OF THE PIKE RIVER IN JANUARY 1982

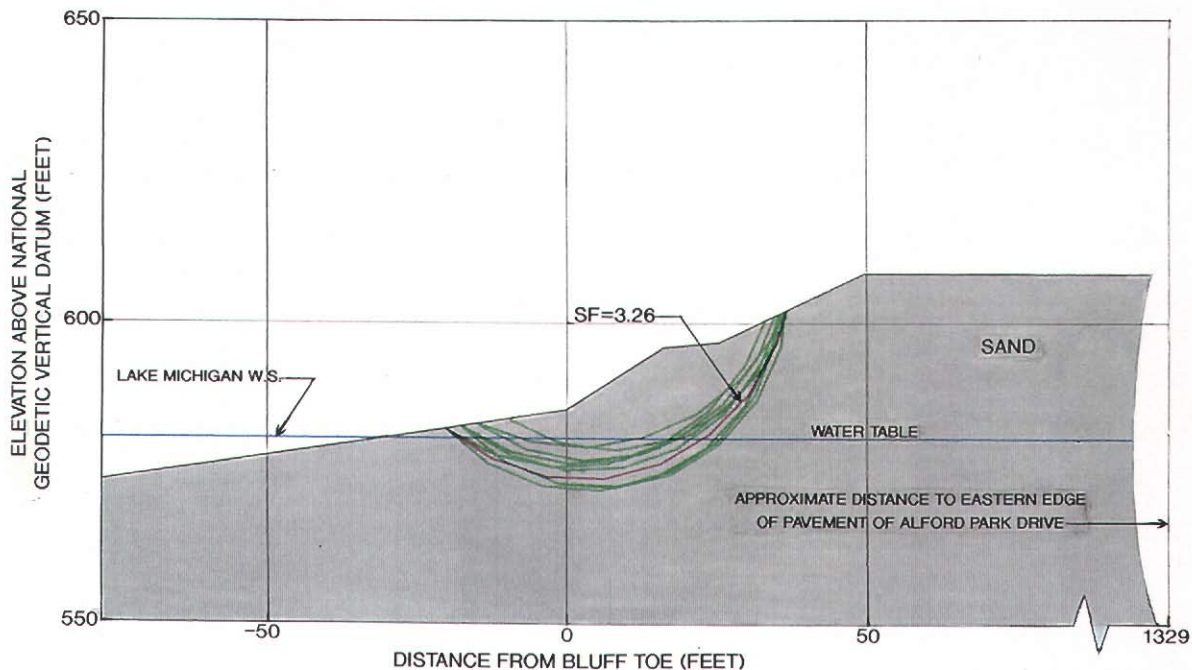
PROFILE: 3-5

of the bluff in Zone 19c of Reach 3 was characterized by Profile No. 3-5. No erosion of the bluff was observed during the 1995 survey and the bluff appeared to be

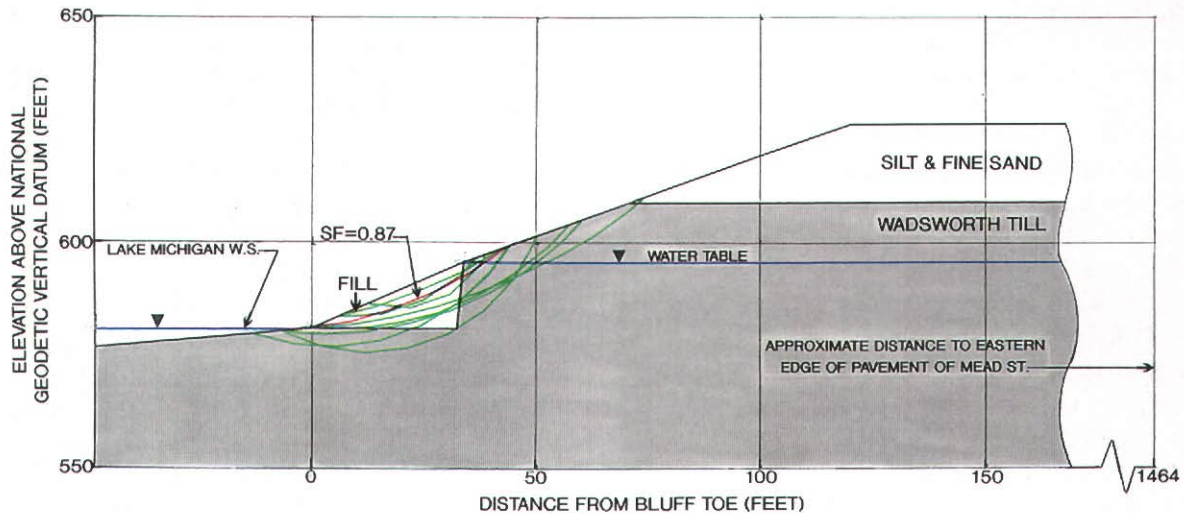
PROFILE: 4-1

of five feet was reached at about 17 feet offshore in 1995. In 1976, the nearshore lake bed depth of five feet was reached at about 20 feet offshore at Profile No. 4-1 and at about 25 feet offshore at Profile No. 4-2. The offshore surface materials observed during 1976 were gravel in the northern portion of the section, and gravel and rocks in the southern portion.

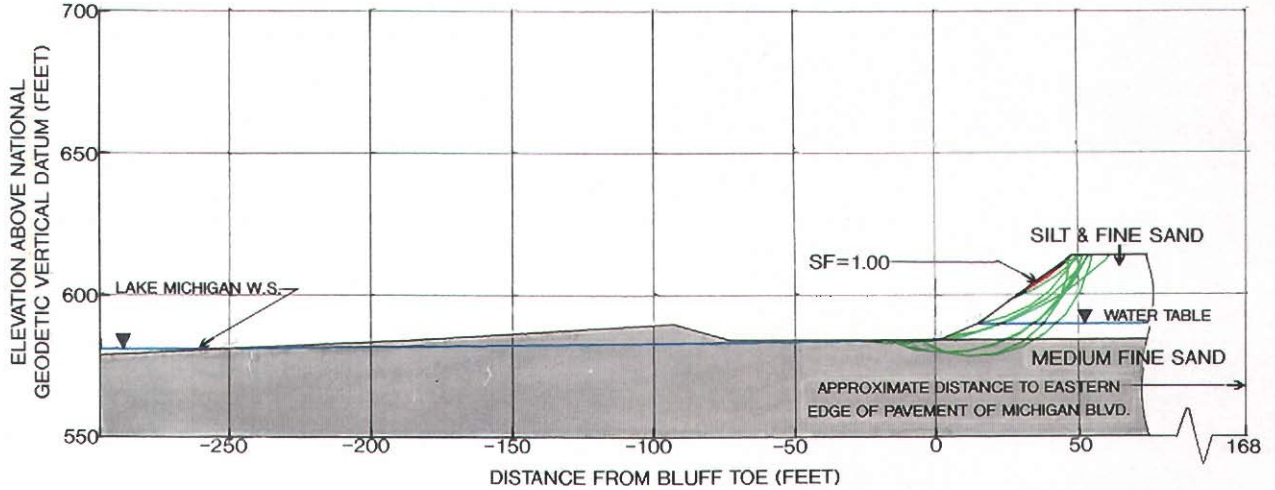
PROFILE: 5-1

In 1995, two bluff profile field surveys were made within Section 4, both by reoccupying sites of field surveys conducted in 1976. Both sites had a similar site geometry in 1995, to that documented in 1976. Profile No. 5-1 was located in the southern portion of the section where Chatham Street makes a left-hand turn along the southern boundary of the Zoological Gardens, adjacent to the southern boundary of the Zoological Gardens. Profile No. 5-2 was centrally located within the reach at the point where Gould Street intersected the shoreline. The sites had significantly different geometries to those documented in 1976. Profile No. 5-1 was least different, with minor changes in the shape of the beach dunes fronting the bluff. One dune was observed at this site in 1995 in contrast to the two or three dunes reported in the 1977 study. Profile No. 5-2 was most different, with a low beach dune at the bluff toe and a vertical slope immediately below the bluff crest being observed in 1995. These features were not reported at this site in the 1977 study. The stability of the bluff in Section 4 of Reach 5 was characterized by Profile Nos. 5-1 and 5-2. Results of the slope stability analysis, shown in Figure 18, indicated the bluff was marginally stable, with safety factors of 1.0 at Profile No. 5-1 and 1.09 at Profile No. 5-2, based upon the deterministic bluff stability analysis method. Profile Nos. 5-1 and 5-2 were also analyzed using the probabilistic bluff stability analysis method which resulted in a range of safety factors from 0.88 to 1.56 for both sites. Profile No. 5-1 had a range in safety factors from 0.88 to 1.46 for the 250 conditions considered. The analytical results indicated a safety factor of less than 1.0 for 13, or 52 percent, of the 25 critical conditions, as represented by the set of most critical conditions determined in each of the 25 analyses considered. In addition, a safety factor of less than 1.0 was determined for 26, or 10.4 percent, of the 250 conditions analyzed. Profile No. 5-2 had a range in safety factors from 0.95 to 1.56 for the 250 conditions considered. The analytical results indicated a safety factor of less than 1.0 for four, or 16 percent, of the 25 critical conditions, as represented by the set of most critical conditions determined in each of the 25 analyses considered. In addition, a safety factor of less than 1.0 was determined for four, or 1.6 percent, of the 250 conditions analyzed. Given the analytical results and the 1995 field observations, the bluff at Profile No. 5-1 was

considered unstable, and the bluff at Profile No. 5-2 was considered marginally stable with the possibility of both rotational and translational failures. The 1977 study reported a bluff safety factor of 1.0 at both sites.

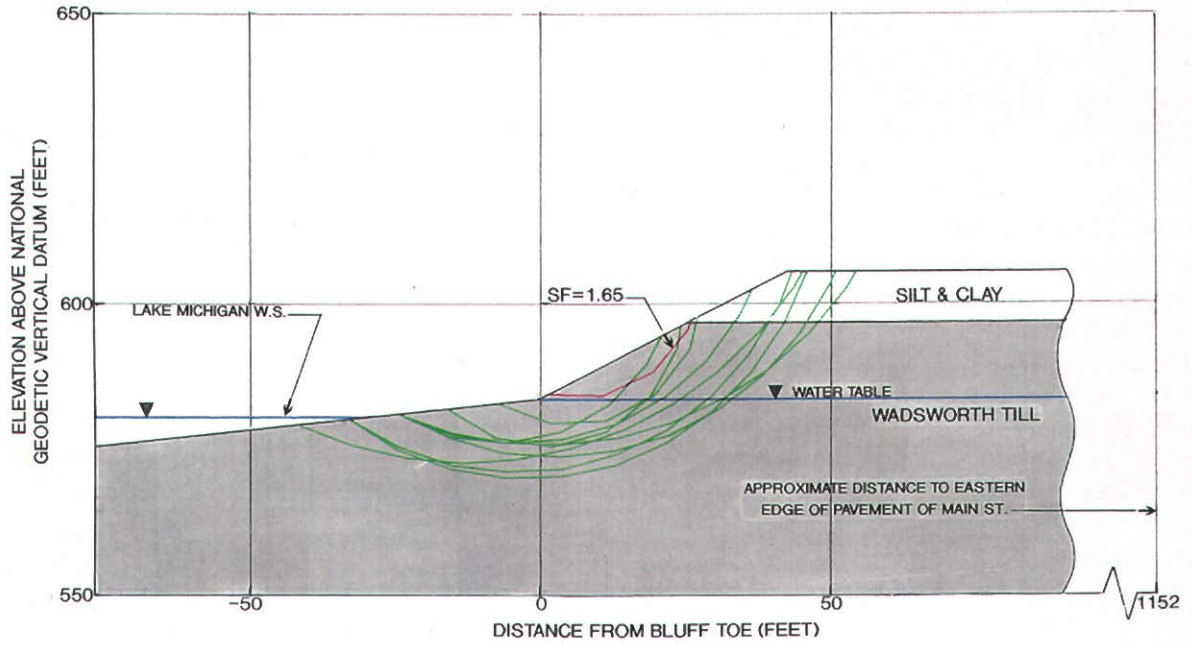
PROFILE: 5-3

stability of the bluff in Erosion Zone 33b of Reach 5 was characterized by Profile No. 5-3. Results of the slope stability analysis, shown in Figure 19, indicated the bluff was stable with respect to rotational failures, with a safety factor of 1.65. Field observations indicated that translational failures are also possible. The 1977 study reported a bluff safety factor of 0.89.

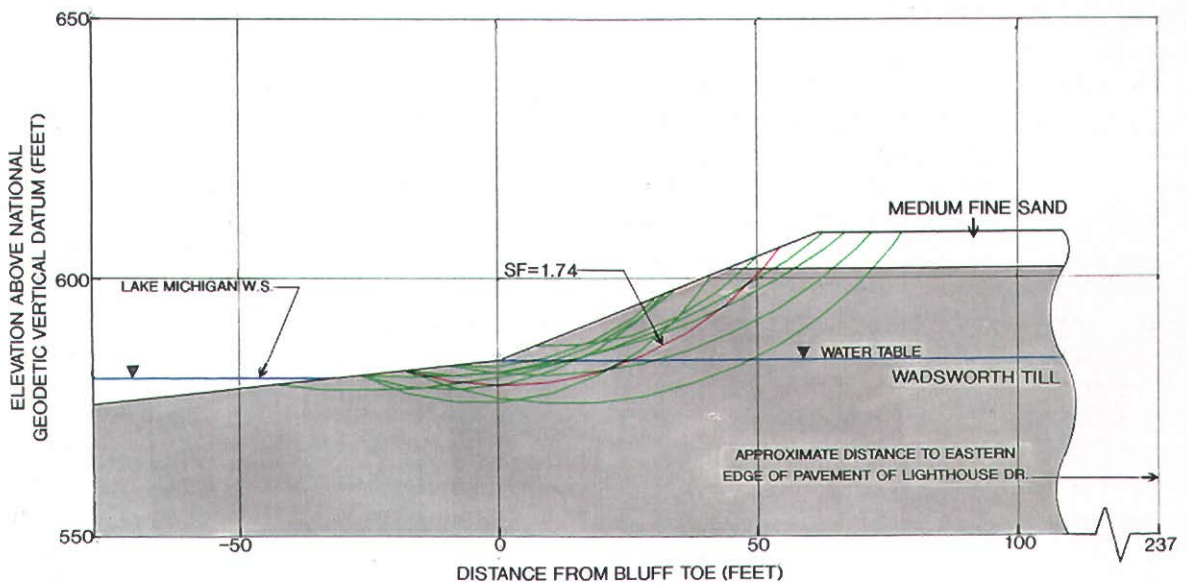
PROFILE: 5-4

was conducted in 1976. The site had a similar geometry to that which was documented in 1976, although the bluff slope appeared to be less steep. The stability of the bluff in Zone 33c of Reach 5 was characterized by Profile No. 5-4. Results of the slope stability analysis, shown in Figure 19, indicated that the bluff was stable with respect to rotational failures, with a safety factor of 1.74. Field observations indicated that shallow translational failures are possible in this zone. The 1977 study reported a bluff safety factor of 0.85.

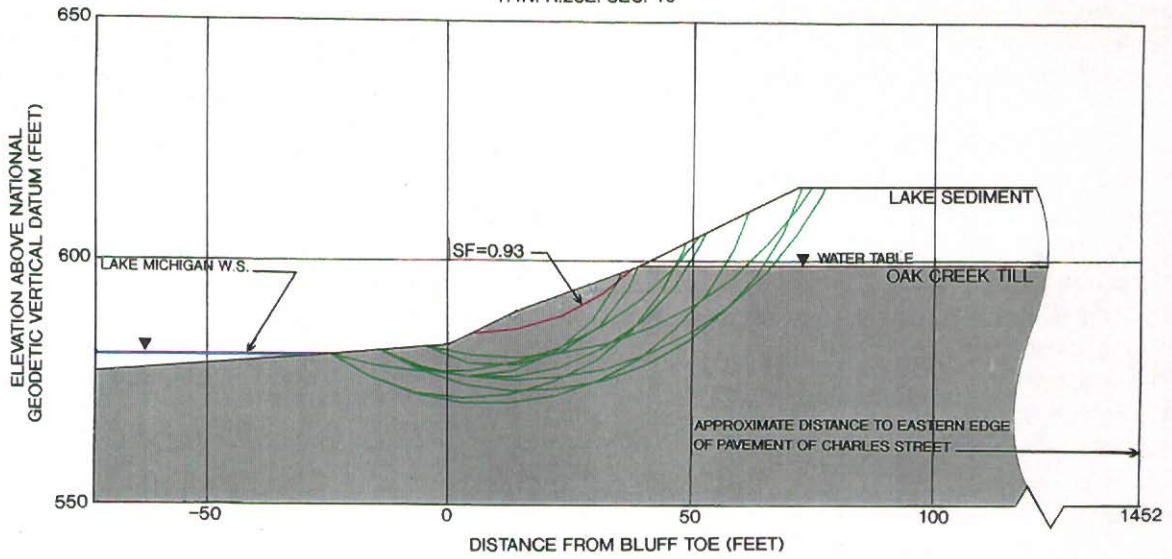
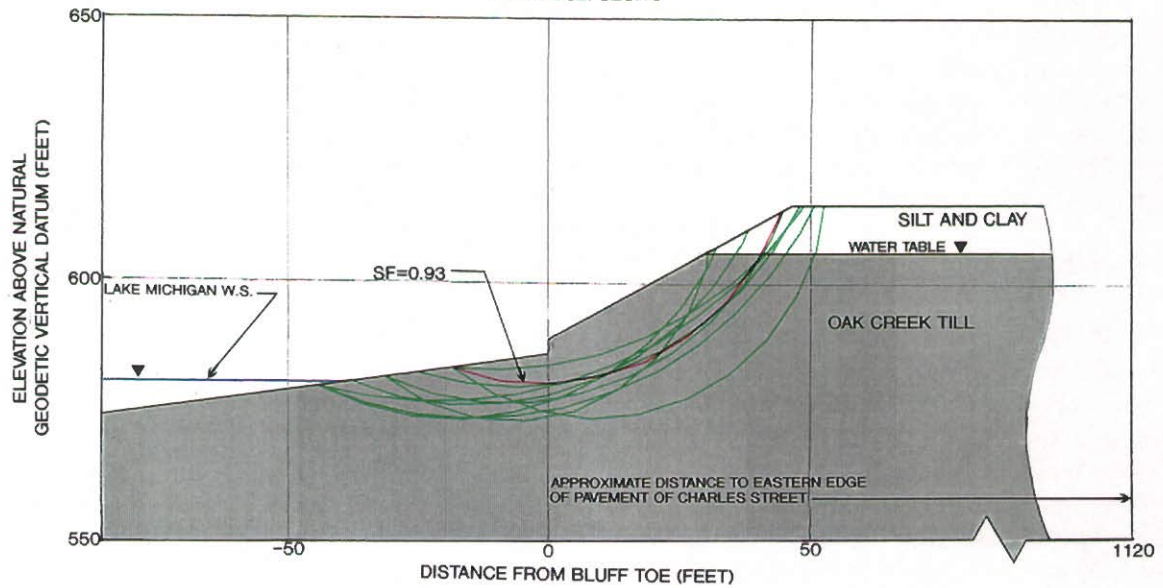
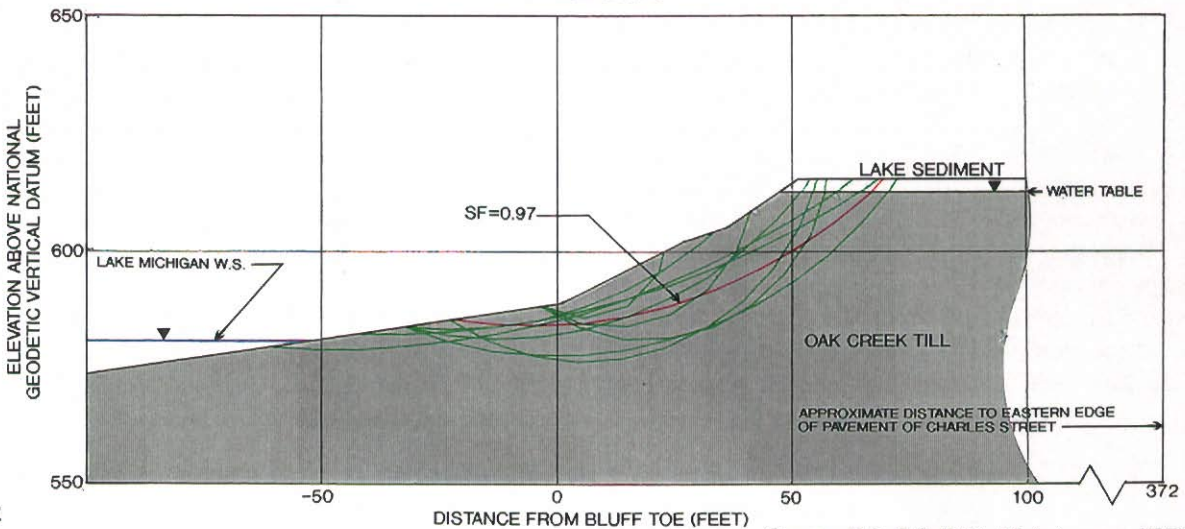
Figure 23
DETERMINISTIC BLUFF SLOPE STABILITY ANALYSES
 U.S. Public Land Survey Section 16, Township 4 North, Range 23 East
 Town of Caledonia, Racine County
PROFILE 6-5
 T.4N. R.23E. SEC. 16

regrading. Also in 1995, five bluff profile field surveys were made within Zone 16b by occupying sites for which field surveys were conducted in 1982. The stability of the bluffs in Zone 16b of Reach 6 was characterized by Profile Nos. 6-5 through 6-11. Results of the slope stability analysis, shown in Figures 23 through 25, indicated that the bluffs were marginally unstable, with safety factors ranging from 0.93 to 0.98 in the southern half of the zone, to stable, with safety factors ranging from 1.25 to 1.53 in the northern half of the zone, based upon the deterministic bluff stability analysis method. Profile Nos. 6-5 through 6-8 were also analyzed using the probabilistic bluff stability analysis method. At Profile No. 6-5, the probabilistic bluff stability analysis resulted in a range of safety factors from 0.79 to 1.78 for the 250 conditions considered. The analytical results indicated a safety factor of less than 1.0 for 21, or 84 percent, of the 25 critical conditions, as represented by the set of most critical conditions determined in each of the 25 analyses considered. In addition, a safety factor of less than 1.0 was determined for 23, or 9.2 percent, of the 250 conditions analyzed. At Profile No. 6-6, the probabilistic bluff stability analysis resulted in a range of safety factors from 0.83 to 1.39 for the 250 conditions considered. The analytical results indicated a safety factor of less than 1.0 for 11, or 44 percent, of the 25 critical conditions, as represented by the set of most critical conditions determined in each of the 25 analyses considered. In addition, a safety factor of less than 1.0 was determined for 29, or 11.6 percent, of the 250 conditions analyzed. At Profile No. 6-7, the probabilistic bluff stability analysis resulted in a range of safety factors from 0.74 to 1.32 for the 250 conditions considered. The analytical results indicated a safety factor of less than 1.0 for 21, or 84 percent, of the 25 critical conditions, as represented by the set of most critical conditions determined in each of the 25 analyses considered. In addition, a safety factor of less than 1.0 was determined for 119, or 47.6 percent, of the 250 conditions analyzed. At Profile No. 6-8, the probabilistic bluff stability analysis resulted in a range of safety factors from 0.94 to 1.44 for the 250 conditions considered. The analytical results indicated a safety factor of less than 1.0 for 11, or 44 percent, of the 25 critical conditions, as represented by the set of most critical conditions determined in each of the 25 analyses considered. In addition, a safety factor of less than 1.0 was determined for 11.6 percent of the 250 conditions analyzed. Given the analytical results and the 1995 field observations, the bluffs were considered marginally unstable at Profile Nos. 6-5, 6-6, and 6-8, and unstable at Profile No. 6-7. Shallow slides occurred intermittently throughout this zone in 1995. The 1977 study reported

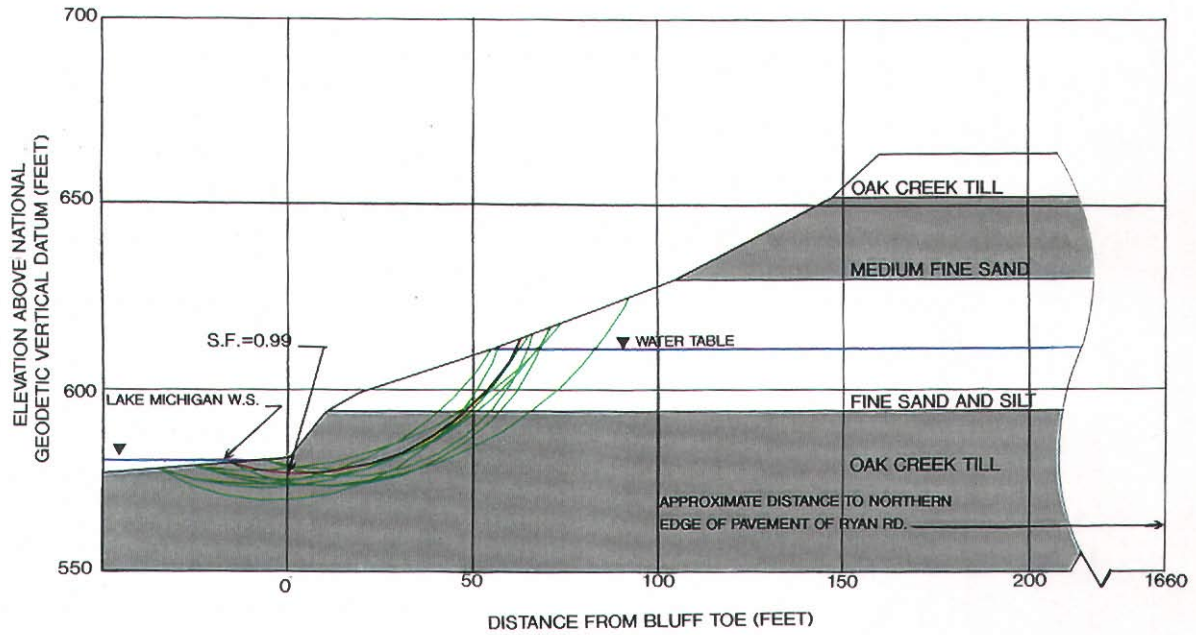
PROFILE 7-8
T.5N. R.22E. S.24

had a safety factor of 1.47, based upon the deterministic bluff stability analysis method. Profile No. 7-8 was also analyzed using the probabilistic bluff stability analysis method which resulted in a range of safety factors from 0.87 to 1.42 for the 250 conditions considered. The analytical results indicated a safety factor of less than 1.0 for five, or 20 percent, of the 25 critical conditions, as represented by the set of most critical conditions determined in each of the 25 analyses considered. In addition, a safety factor of less than 1.0 was determined for 29, or 11.6 percent, of the 250 conditions analyzed. Given the analytical results and the 1995 field observations, the bluffs were considered marginally stable with respect to both rotational and translational failures. The 1977 study reported a bluff safety factor of 0.54. The 1987 study reported bluff safety factors of between 0.86 and 0.87.

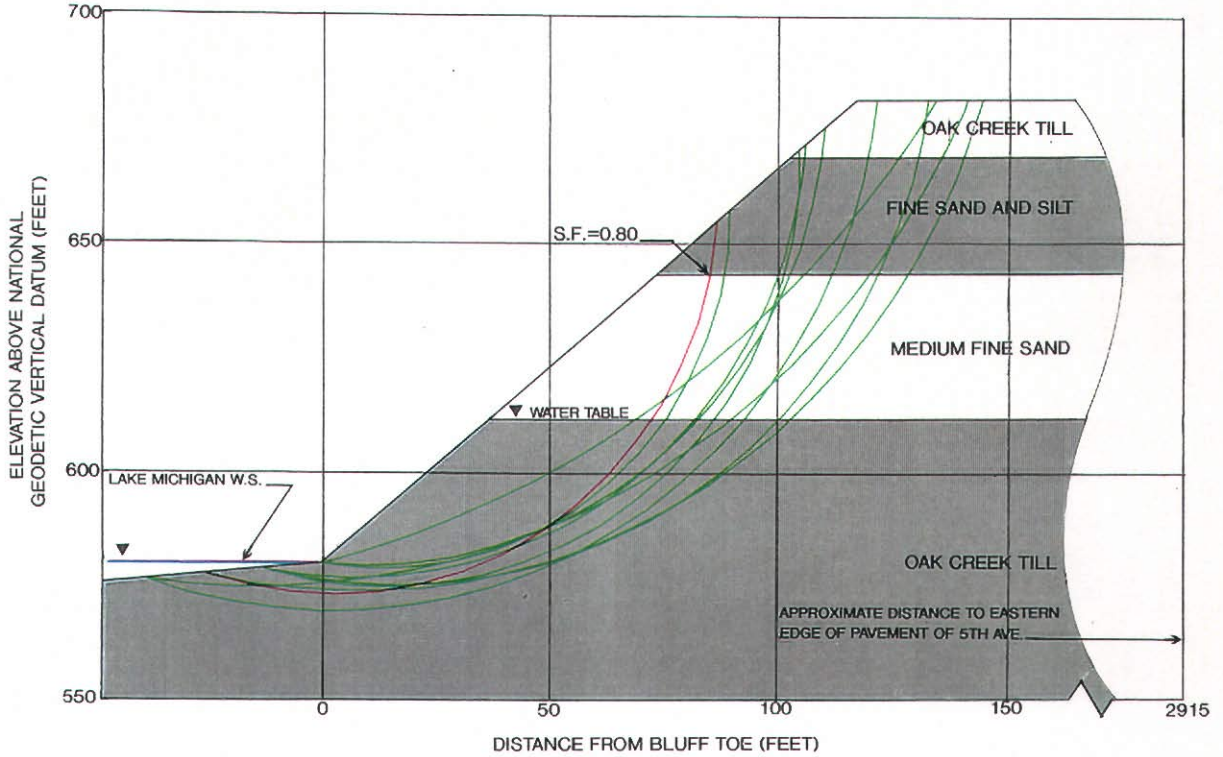
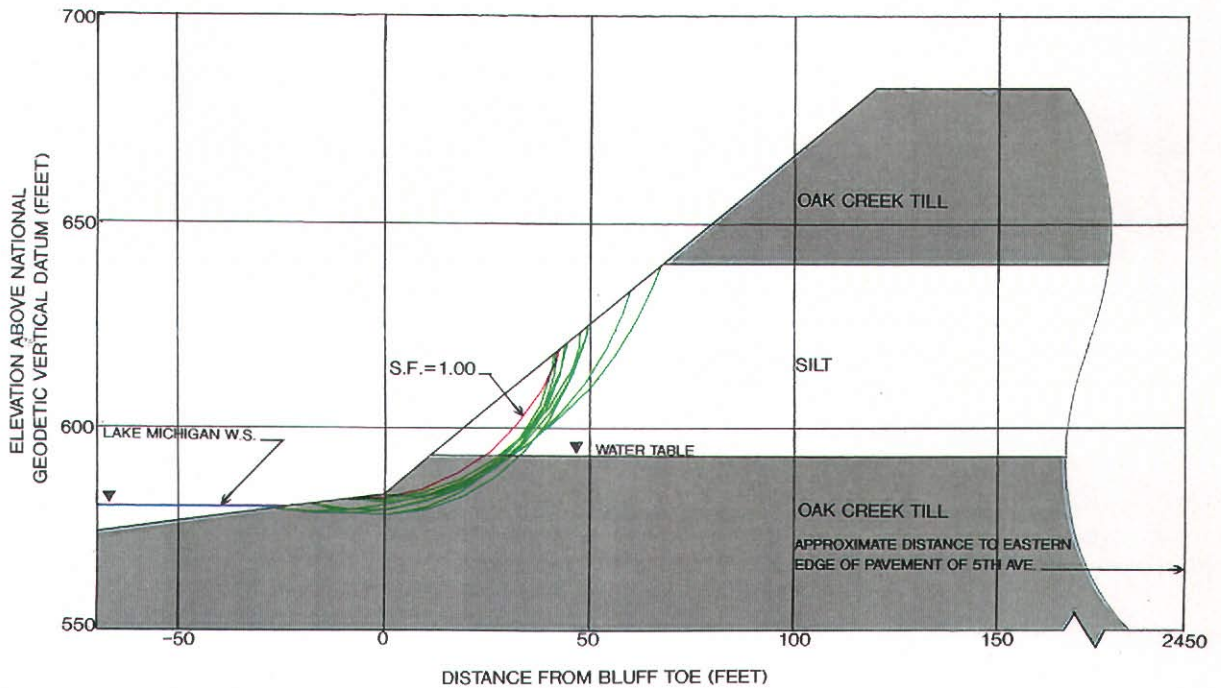
PROFILE 7-11
T.5N. R.22E. S.24

bluff in Zone 24b of Reach 7 was characterized by Profile No. 7-11. Results of the slope stability analysis, shown in Figure 33, indicated that the bluff was unstable, with a safety factor of 0.99, based upon the deterministic bluff stability analysis method. Profile No. 7-11 was also analyzed using the probabilistic bluff stability analysis method which resulted in a range of safety factors from 0.76 to 1.12 for the 250 conditions considered. The analytical results indicated a safety factor of less than 1.0 for 23, or 92 percent, of the 25 critical conditions, as represented by the set of most critical conditions determined in each of the 25 analyses considered. In addition, a safety factor of less than 1.0 was determined for 179, or 71.6 percent, of the 250 conditions analyzed. Given the analytical results and the 1995 field observations, the bluffs were considered unstable with respect to both rotational and translational failures. The 1987 study reported a bluff safety factor of 0.92.

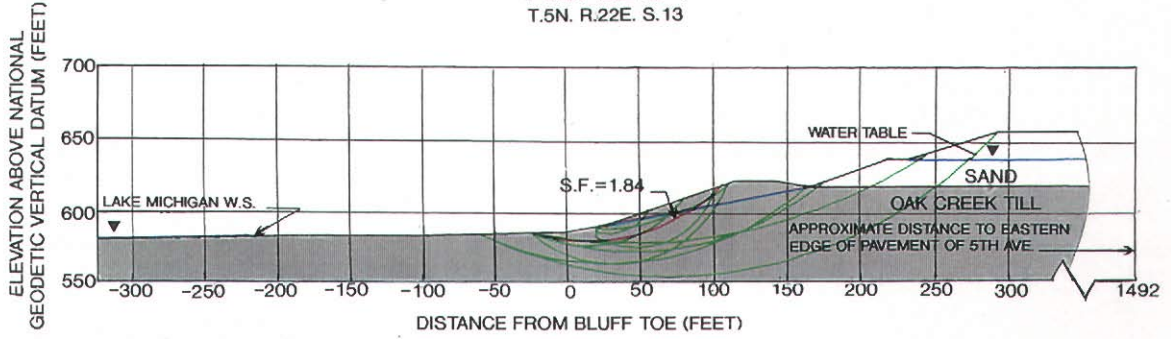
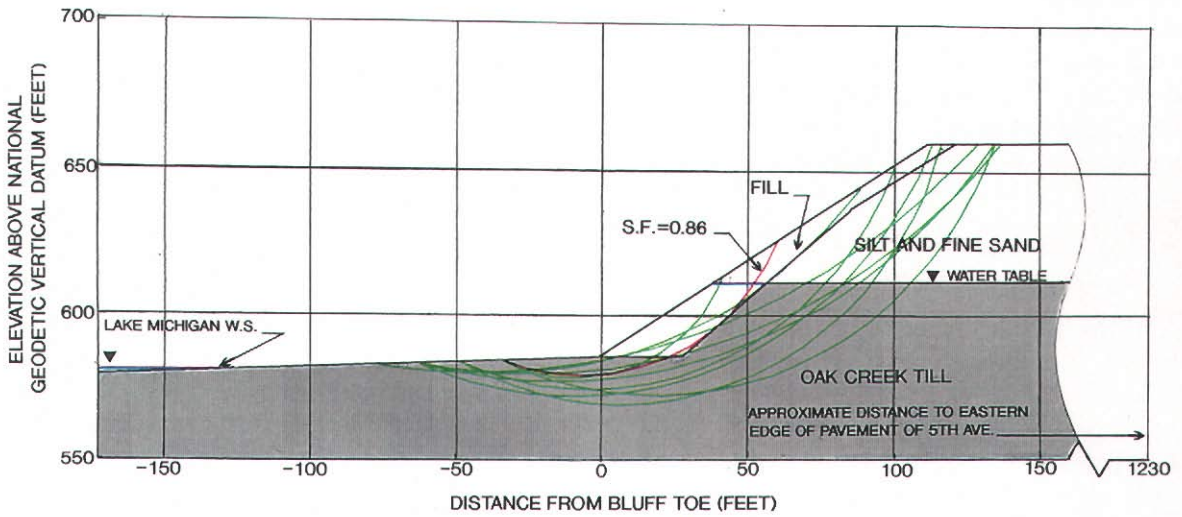
In 1995, two bluff profile field surveys were made within Zone 13a by occupying sites for which field surveys were conducted in 1987. The reoccupied sites had significantly different geometries to those documents in 1987. The two sites appeared to have become less steeply sloped. The stability of the bluff in Zone 13a of Reach 8 was characterized by Profile Nos. 8-1 and 8-2. Results of the slope stability analysis, shown in Figure 35, indicated that the bluff was stable in the southern portion of the zone, with a safety factor of 1.84 at Profile No. 8-1, and unstable with respect to both rotational and translational failures in the northern portion of the zone, with a safety factor of 0.86 at Profile No. 8-2. The 1987 study reported bluff safety factors of 1.48 and 0.74 at Profile Nos. 8-1 and 8-2, respectively.

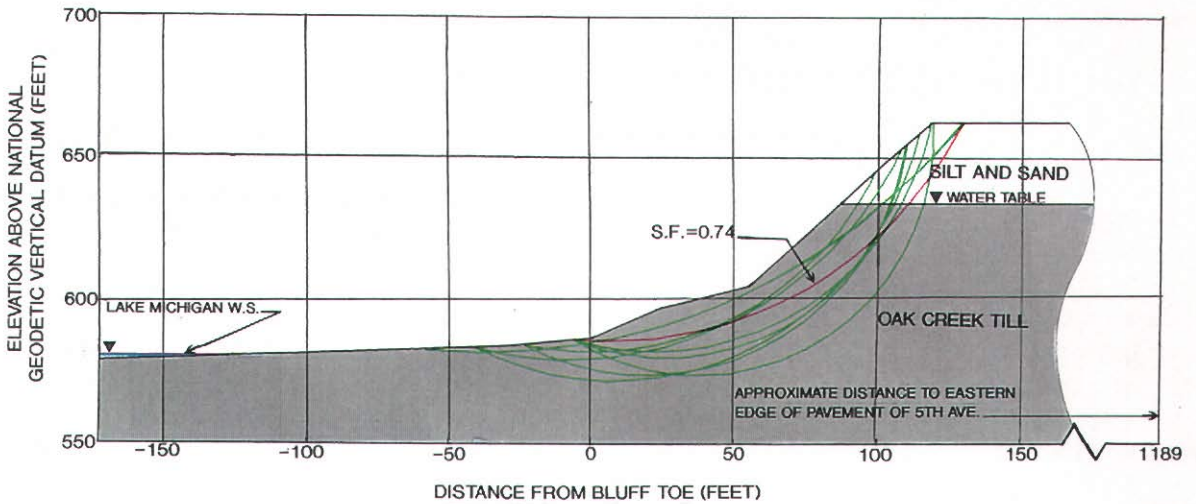
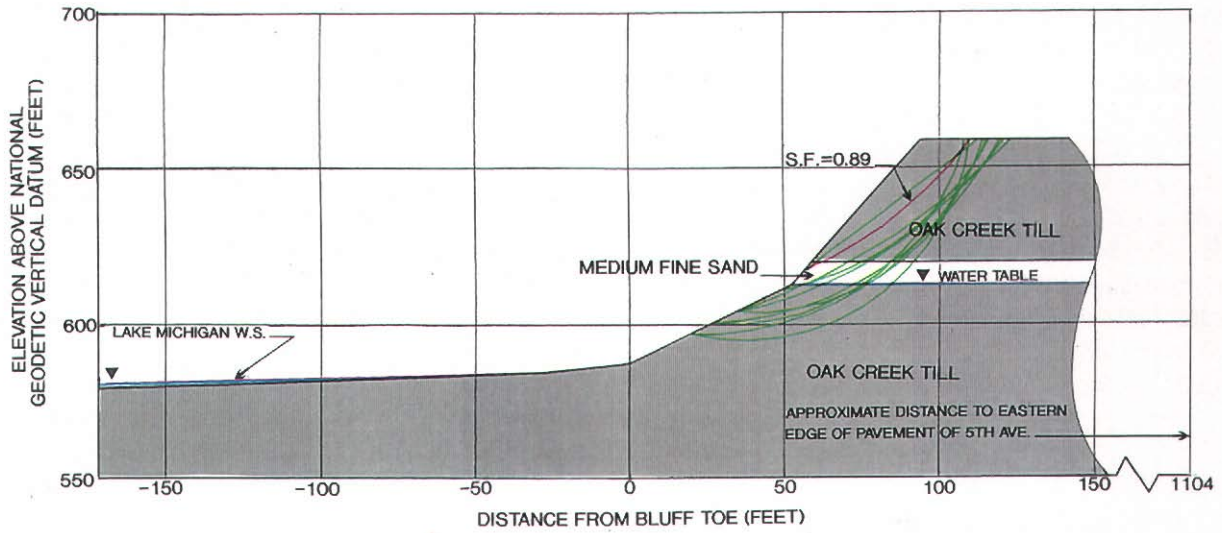
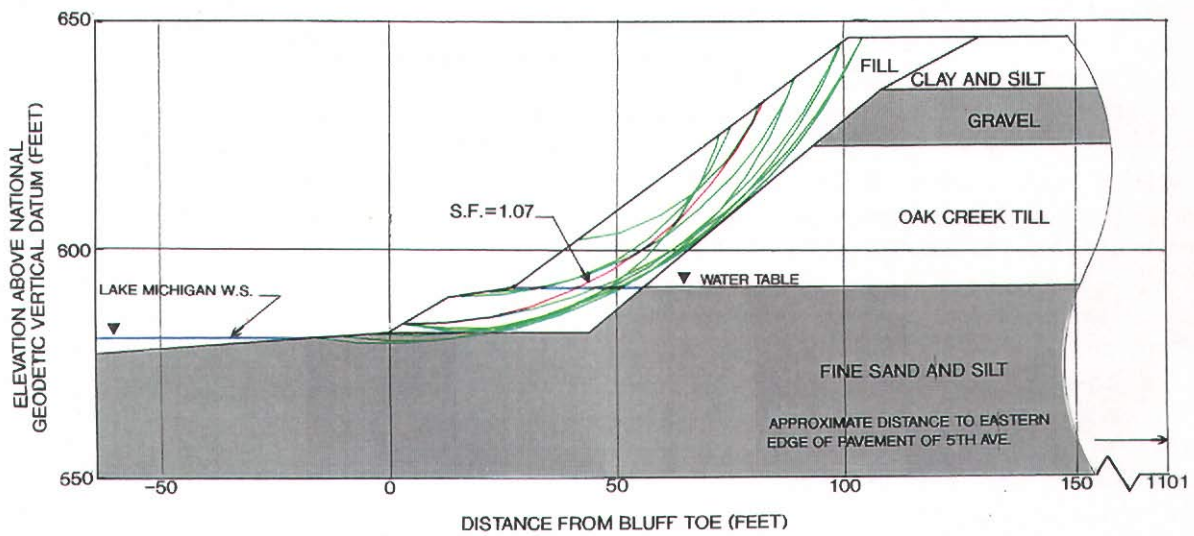
In 1995, one bluff profile field survey was made within Zone 13b by occupying a site for which a field survey was conducted in 1976. The reoccupied site had a significantly different geometry that documented in 1976. In the southern portion of the zone, Profile No. 8-3 appeared to have become less steeply sloped. Also in 1995, two bluff profile surveys were made within Zone 13b by occupying sites for which field surveys were conducted in 1987. The reoccupied sites had significantly different geometries to those documented in 1987. The two sites appeared to have become less steeply sloped, with the northernmost site at Profile No. 8-5 having been significantly modified by the placement of fill. The stability of the bluff in Zone 13b of Reach 8 was characterized by Profile Nos. 8-3 through 8-5. Results of the slope stability analysis, shown in Figures 35 and 36, indicated that the bluff was unstable with respect to both rotational and translational failures in the southern portion of the zone, with safety factors ranging from 0.74 at Profile No. 8-3 to 0.89 at Profile No. 8-4. At Profile No. 8-5 in the northern portion of the zone, the results of the slope stability analysis, shown in Figure 36, indicated that the bluff was marginally stable, with a safety factor of 1.07. The 1977 study reported bluff safety factors of 0.97 for the entire bluff face and 0.34 for the scarp slope at the top of the bluff. The 1987 study reported bluff safety factors of 0.74 to 1.13, with the more stable slope being located at Profile No. 8-5. The 1995 field observations indicated that translational failures may occur throughout this zone.

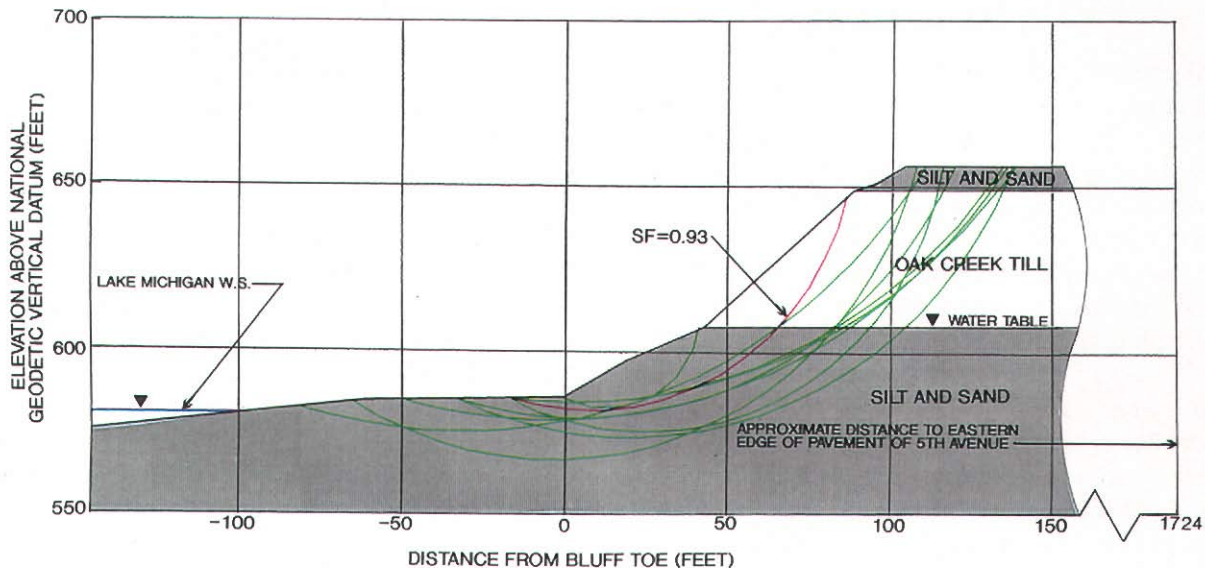
PROFILE 8-10
T.5N. R.22E. S.12

In the current study, one bluff profile survey was made within Erosion Zone 12b, by reoccupying the site for which a field survey was conducted in 1976. The site at Profile No. 8-10 had a significantly different geometry to that documented in 1976. The bluff slope appeared to have become steeper. The stability of the bluff in Erosion Zone 12b of Reach 8 was characterized by Profile No. 8-10. Results of the slope stability analyses, shown in Figure 39, indicated that the bluff was unstable, with a safety factor of 0.93, based upon the deterministic bluff stability analysis method. Profile No. 8-10 was also analyzed using the probabilistic bluff stability analysis method which resulted in a range of safety factors from 0.82 to 1.47 for the 250 conditions considered. The analytical results indicated a safety factor of less than 1.0 for 11, or 44 percent, of the 25 critical conditions, as represented by the set of most critical conditions determined in each of the 25 analyses considered. In addition, a safety factor of less than 1.0 was determined for 46, or 18.4 percent, of the 250 conditions analyzed. Given the analytical results and the 1995 field observations, the bluffs were considered marginally stable with respect to both rotational and translational failures. The 1977 study reported a bluff safety factor of 0.78.

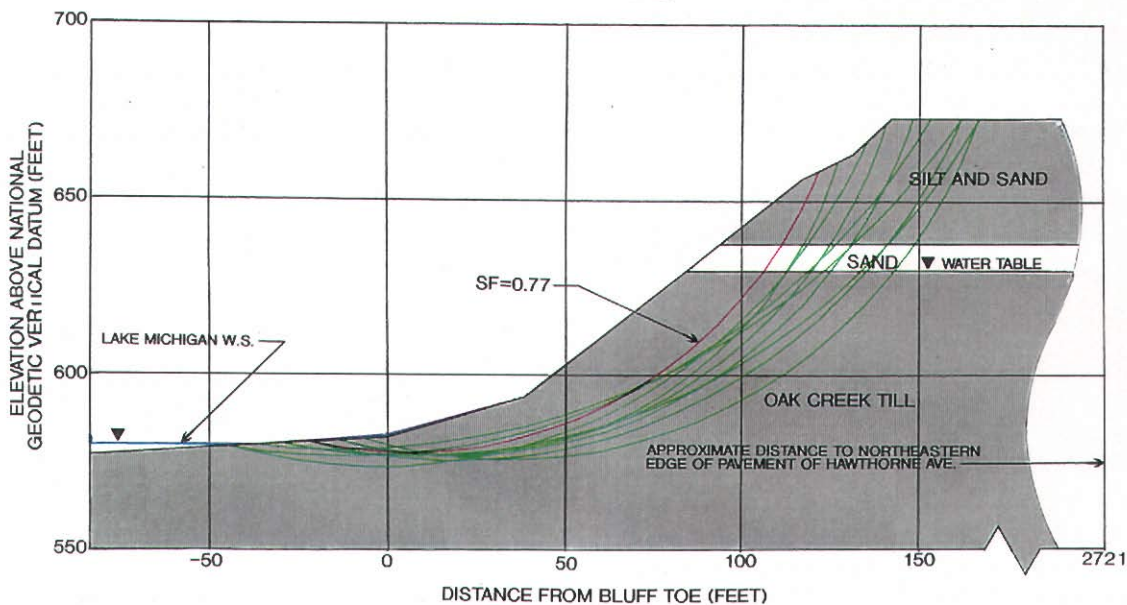
PROFILE 8-11
T.5N. R.22E. S.12

In 1995, one bluff profile field survey was made within Zone 12d by occupying a site for which a field survey was conducted in 1976. The reoccupied site had a significantly different geometry to that documented in 1976. Profile No. 8-11 appeared to have developed a slight bluff scarp at the bluff top, and the material previously accumulated at the bluff toe had been lost. The stability of the bluff in Zone 12d of Reach 8 was characterized by Profile No. 8-11. Results of the slope stability analysis, shown in Figure 39, indicated that the bluff was unstable with respect to both rotational and translational failures, with a safety factor of 0.77. The 1977 study reported a bluff safety factor of 0.82.

In 1995, it appeared that shoreline recession would be likely to continue within Erosion Zone 12d unless measures are implemented to protect the bluff toe. The groin system at the northern extreme of this zone was observed to protect the base of the bluff slope to the north of the groin to a degree, but immediately south of the southern groin the beach was narrow enough in 1995 that the bluff toe was being cut by waves. At this location, the bluff slope was steep and lacked vegetative cover. Hence, it was anticipated that the steeper part of the bluff would move upslope and eventually produce bluff top retreat.

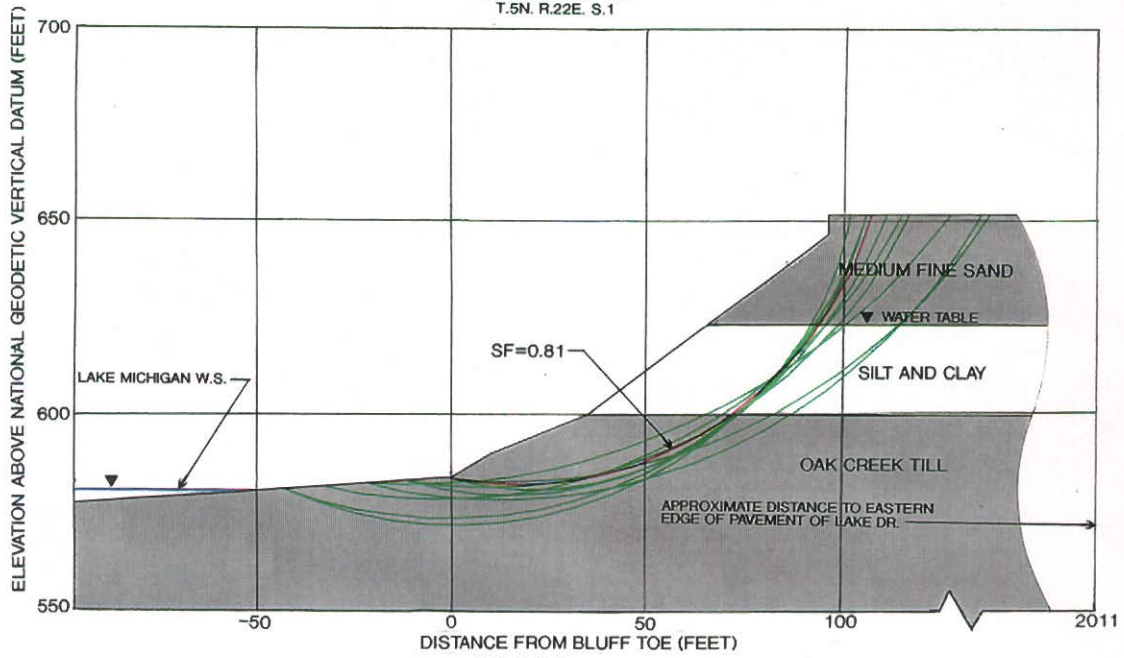
PROFILE 8-15
T.5N. R.22E. S.1

cantly different geometries to those documented in 1976. The shapes of the bluff had become less steep, with a scarp having developed at Profile No. 8-15. Also in 1995, two bluff profile field surveys were made within Zone 1b by occupying sites for which field surveys were conducted in 1987. The sites had significantly different geometries to those documented in 1987. The shape of the bluffs had become less steep. The proximity of Profile No. 8-15, which coincided with a 1976 bluff profile field survey site, to that of a third 1987 bluff profile field survey site, would suggest that little further change in the geometry of that site occurred subsequent to 1987. The stability of the bluffs in Zone 1b of Reach 8 was characterized by Profile Nos. 8-14 through 8-18. Results of the slope stability analyses, shown in Figures 41 and 42, indicated that the bluff was marginally stable to stable in the extreme south of the zone and in the central portions of the zone at Profile Nos. 8-14, 8-16, and 8-17, with bluff safety factors ranging from 1.07 to 1.21; unstable in the southern portion of the zone, with a bluff safety factor of 0.81; and, marginally unstable in the extreme northern portion of the zone, with a bluff safety factor of 0.98, based upon the deterministic bluff stability analysis method. Profile No. 8-18 was also analyzed using the probabilistic bluff stability analysis method. At Profile No. 8-18, the probabilistic bluff stability analysis method resulted in a range of safety factors from 0.59 to 1.28 for the 250 conditions considered. The analytical results indicated a safety factor of less than 1.0 for 16, or 64 percent, of the 25 critical conditions, as represented by the set of most critical conditions determined in each of the 25 analyses considered. In addition, a safety factor of less than 1.0 was determined for 108, or 43.2 percent, of the 250 conditions analyzed. Given the analytical results and the 1995 field observations, the bluffs were considered marginally stable with respect to both rotational and translational failures. The 1977 study reported bluff safety factors of between 0.4 and 0.51. The 1987 study reported bluff safety factors of between 0.86 and 1.23, with the least stable portions of the bluff located in the southern and central portions of the zone.

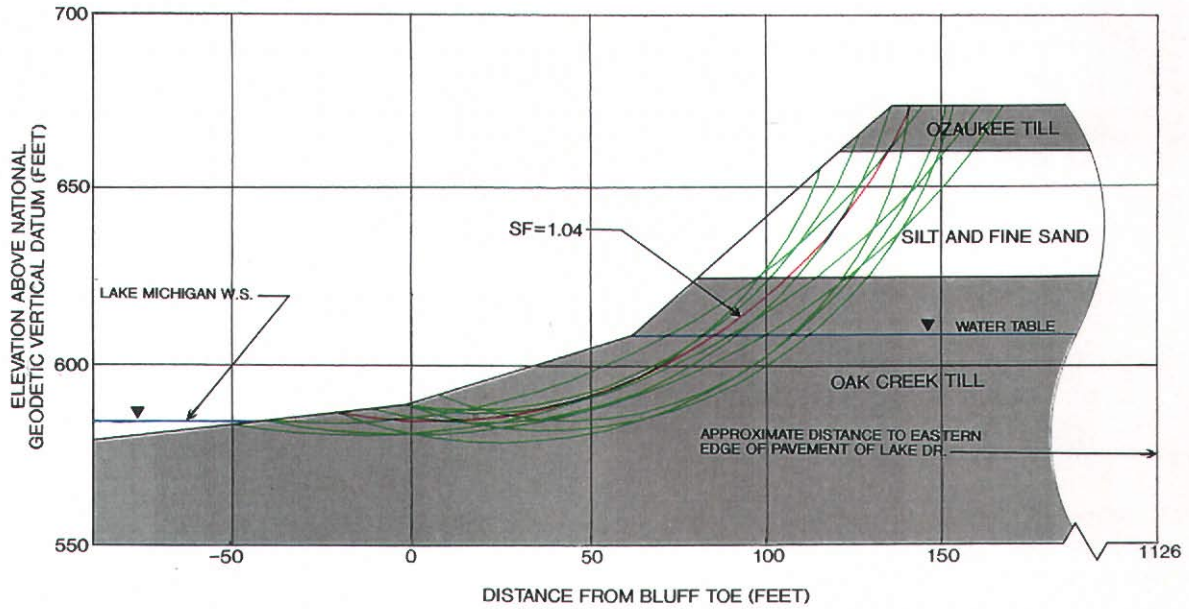
PROFILE 8-19
T.6N. R.22E. S.36

In 1995, two bluff profile field surveys were made within Zone 36a by occupying sites for which field surveys were conducted in 1976. At Profile No. 8-19 in the southern portion of the zone and at Profile No. 8-22 in the northern portion of the zone, the bluff had slightly different geometries to those documented in 1976. The shape of the bluff had become generally less steep. The steeply sloping scarps at the bluff toe, most pronounced at Profile No. 8-22 in 1976, was not observed in 1995. Also in 1995, two bluff profile field surveys were made within Zone 36a by occupying sites for which field surveys were conducted in 1987. A third site, occupied in 1987, but not reoccupied in 1995, was located in close proximity to Profile No. 8-19. At Profile Nos. 8-20 and 8-21 in the central portion of the zone, the bluff had a slightly different geometry to that documented in 1987. The shape of the bluff had become less steep. At Profile No. 8-19, assuming this site to be representative of the adjacent 1987 site shown on Map 44, the slope had a significantly different geometry to that documented in 1987, being considerably less steeply sloping. The stability of the bluff in Zone 36a of Reach 8 was characterized by Profile Nos. 8-19 through 8-22. Results of the slope stability analysis, shown in Figures 43 and 44, indicated that the bluff was unstable to marginally stable in the zone, with safety factors ranging from 0.76 to 1.04, based upon the deterministic bluff stability analysis method. Profile Nos. 8-19 and 8-22 were also analyzed using the probabilistic bluff stability analysis method. At Profile No. 8-19, the probabilistic bluff stability analysis method resulted in a

range of safety factors from 0.82 to 1.2 for the 250 conditions considered. The analytical results indicated a safety factor of less than 1.0 for 12, or 48 percent, of the 25 critical conditions, as represented by the set of most critical conditions determined in each of the 25 analyses considered. In addition, a safety factor of less than 1.0 was determined for 86, or 34.4 percent, of the 250 conditions analyzed. At Profile No. 8-22, the probabilistic bluff stability analysis method resulted in a range of safety factors from 0.71 to 1.17 for the 250 conditions considered. The analytical results indicated a safety factor of less than 1.0 for 18, or 72 percent, of the 25 critical conditions, as represented by the set of most critical conditions determined in each of the 25 analyses considered. In addition, a safety factor of less than 1.0 was determined for 145, or 58 percent, of the 250 conditions analyzed. Given the analytical results and the 1995 field observations, the bluff at Profile No. 8-19 was considered to be marginally stable, and the bluff at Profile No. 8-22 was considered unstable with respect to both rotational and translational failures. The least stable portions of the shoreline were located in the central portion of the zone. The 1977 study reported bluff safety factors of 0.5 in the southern portion of the zone and 1.19 in the northern portion of the zone. The 1987 study reported bluff safety factors of between 0.71 and 1.69, with the stable portion of the bluff slope being located at Profile No. 8-20 in the central portion of the zone.

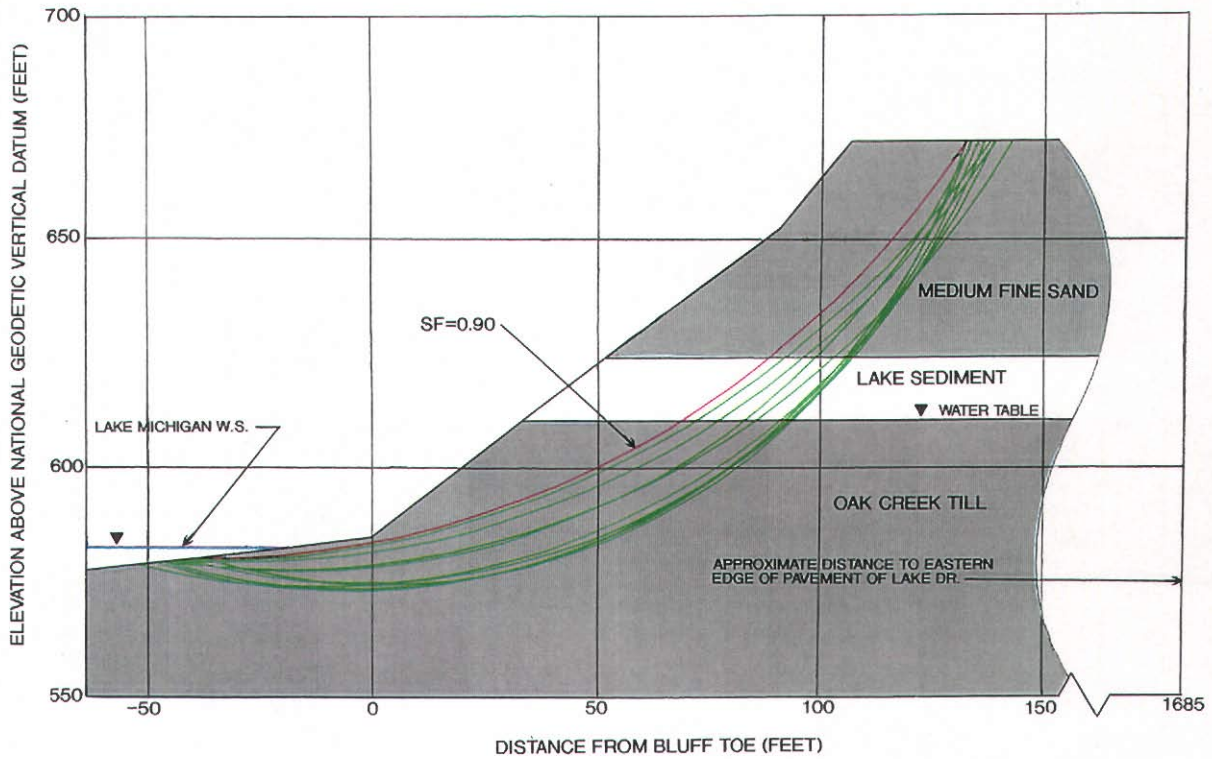
PROFILE 8-24
T.6N. R.22E. S.36

8-25. Results of the slope stability analyses, shown in Figure 45, indicated that the bluff was unstable with respect to both rotational and translational failures, with a bluff safety factor of between 0.79 and 0.90. The 1977 study reported a bluff safety factor of 0.54 at Profile No. 8-24. The 1987 study reported a bluff safety factor of 0.65 at Profile No. 8-25.

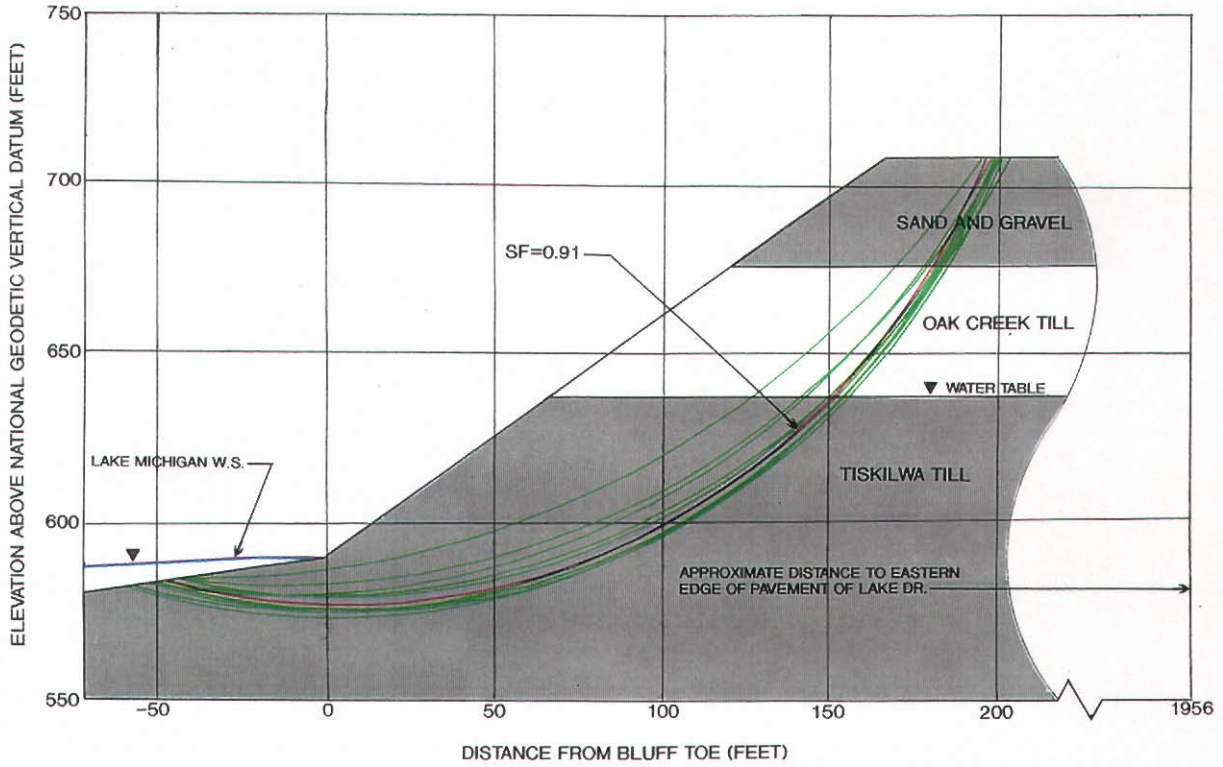
PROFILE 8-26
T.6N. R.22E. S.25

method. At Profile No. 8-26, the probabilistic bluff stability method resulted in a range of safety factors from 0.55 to 0.92 for the 250 conditions considered. The analytical results indicated a safety factor of less than 1.0 for 25, or 100 percent, of the 25 critical conditions, as represented by the set of most critical conditions determined in each of the 25 analyses considered. In addition, a safety factor of less than 1.0 was determined for 250, or 100 percent, of the 250 conditions analyzed. At Profile No. 8-28, the probabilistic bluff stability method resulted in a range of safety factors from 0.76 to 1.29 for the 250 conditions considered. The analytical results indicated a safety factor of less than 1.0 for 12, or 48 percent, of the 25 critical conditions, as represented by the set of most critical conditions determined in each of the 25 analyses considered. In addition, a safety factor of less than 1.0 was determined for 52, or 20.8 percent, of the 250 conditions analyzed. Given the analytical results and the 1995 field observations, the bluff at Profile No. 8-26 was considered unstable, and the bluff at Profile No. 8-28 was considered marginally stable, with respect to both rotational and translational failures. The 1977 study reported bluff safety factors of 0.33 and 0.68 at Profile Nos. 8-26 and 8-27, respectively. The 1987 study reported a bluff safety factor of 0.82 at Profile No. 8-28.
