LAKE MICHIGAN SHORELINE RECESSION AND BLUFF STABILITY IN SOUTHEASTERN WISCONSIN: 1995

TECHNICAL REPORT
NUMBER 36

**LAKE MICHIGAN SHORELINE RECESSION AND
BLUFF STABILITY IN SOUTHEASTERN WISCONSIN: 1995**

Southeastern Wisconsin Regional Planning Commission

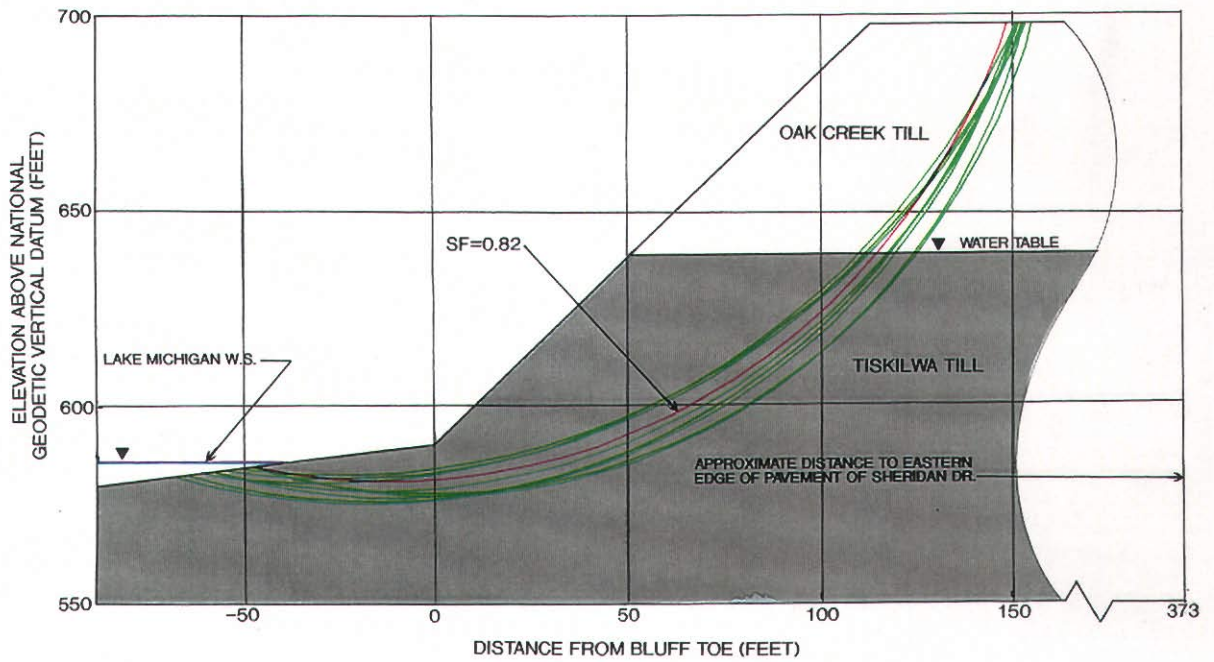
PROFILE 8-29
T.6N. R.22E. S.25

In 1995, two bluff profile field surveys were made within Zone 25b by occupying sites for which field surveys were conducted in 1976. The site at Profile No. 8-30 had a significantly different geometry to that documented in 1976. The shape of the bluff had become less steep. At Profile No. 8-29, the shape of the bluff appeared to be unchanged. The stability of the bluff in Zone 25b of Reach 8 was characterized by Profile Nos. 8-29 and 8-30. Results of the slope stability analyses, shown in Figures 47 and 48, indicated that the bluff was unstable with respect to both rotational and translational failures, with bluff safety factors of 0.74 at Profile No. 8-30 and 0.82 at Profile No. 8-29. The 1977 study reported bluff safety factors of 0.49 and 0.88 at Profile Nos. 8-29 and 8-30, respectively.

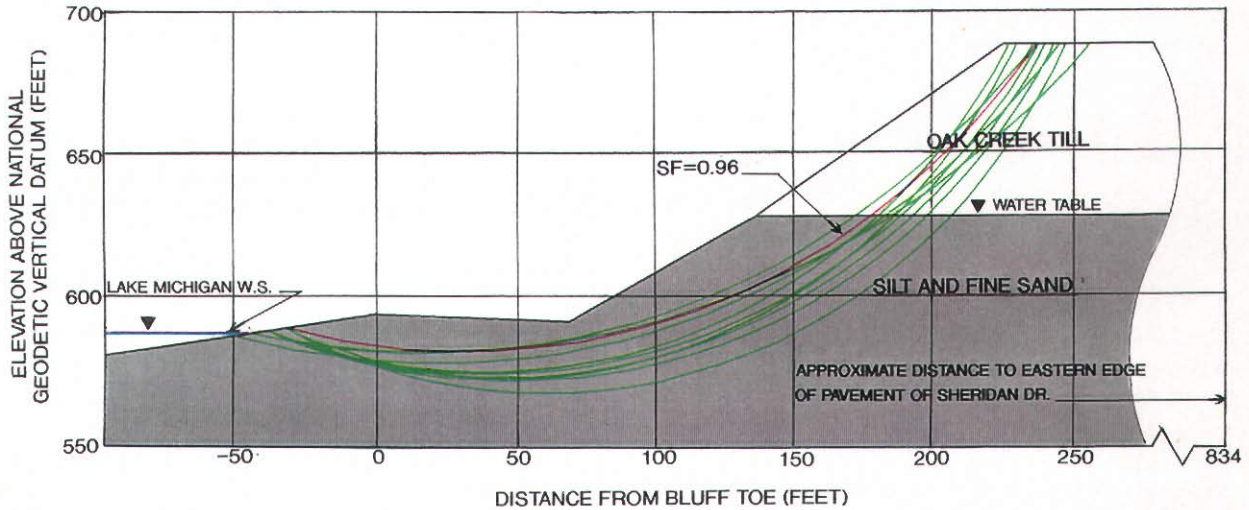
PROFILE 8-34
T.6N. R.22E. S.24

In 1995, one bluff profile field survey was made within Zone 24a by occupying a site for which a field survey was conducted in 1976. The bluff had a significantly different geometry to that documented in 1976. The shape of the bluff had become steeper at Profile No. 8-34, and a beach fronted the bluff. Also in 1995, three bluff profile field surveys were made within Erosion Zone 24a by occupying sites for which field surveys were conducted in 1987. At all three sites, the bluff had a significantly different geometry to that documented in 1987. The shape of the bluff had become less steep. The stability of the bluff in Zone 24a of Reach 8 was characterized by Profile Nos. 8-32 through 8-35. Results of the slope stability analysis, shown in Figures 49 and 50, indicated that the bluff was unstable to marginally stable with respect to deep-seated slumps and shallow slides at Profile Nos. 8-32, 8-34, and 8-35, with safety factors ranging from 0.8 to 1.04, based upon the deterministic bluff stability analysis method. At Profile No. 8-33, the bluff appeared to be stable with respect to rotational failures, with a safety factor of 1.12. Profile Nos. 8-34 and 8-35 were also analyzed using the probabilistic bluff stability analysis method. At Profile No. 8-34, the probabilistic bluff stability analysis resulted in a range of safety factors from 0.72 to 1.18 for the 250 conditions considered. The analytical results indicated a safety factor of less than 1.0 for 25, or 100 percent, of the 25 critical conditions, as represented by the set of most critical conditions determined in each of the 25 analyses considered. In addition, a safety factor of less than 1.0 was determined for 200, or 80 percent, of the 250 conditions analyzed. At Profile No. 8-35, the probabilistic bluff stability analysis resulted in a range of safety factors from 0.89 to 1.58 for the 250 conditions considered. The analytical results indicated a safety factor of less than 1.0 for eight, or 32 percent, of the 25 critical conditions, as represented by the set of most critical conditions determined in each of the 25 analyses considered. In addition, a safety factor of less than 1.0 was determined for 13, or 5.2 percent, of the 250 conditions analyzed. Given the analytical results and the 1995 field observations, the bluff was considered unstable at Profile No. 8-34, and marginally stable at Profile No. 8-35 with respect to both rotational and translational failures. The 1977 study reported a bluff safety factor of 0.6 at Profile No. 8-34. The 1987 study reported

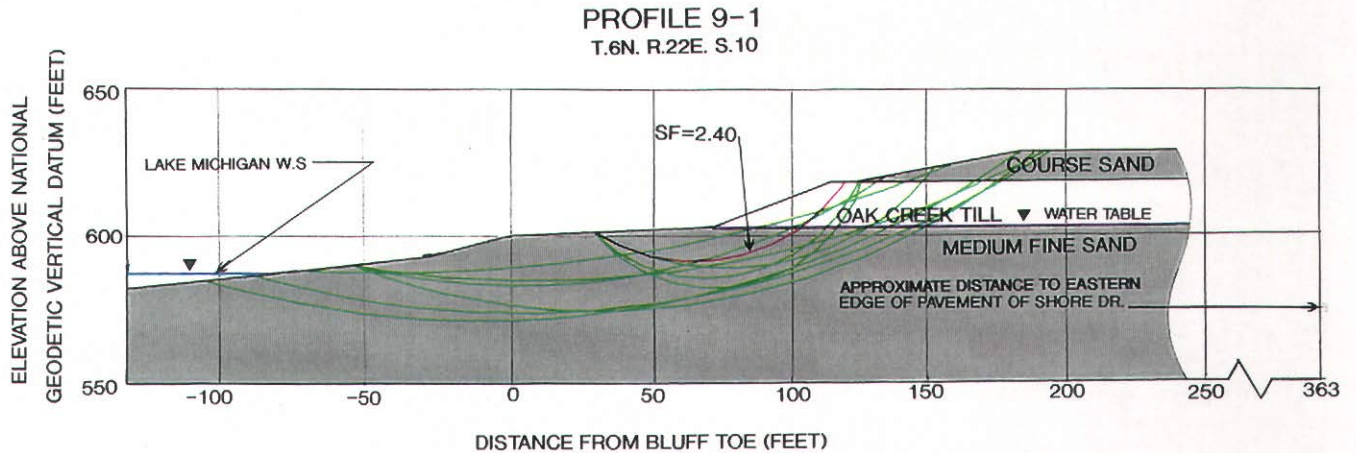
Figure 53

of the slope stability analysis, shown in Figure 53, indicated that the bluff was stable in the southern portion of the section with a safety factor of 2.40. The 1987 study reported a bluff safety factor of 1.21.

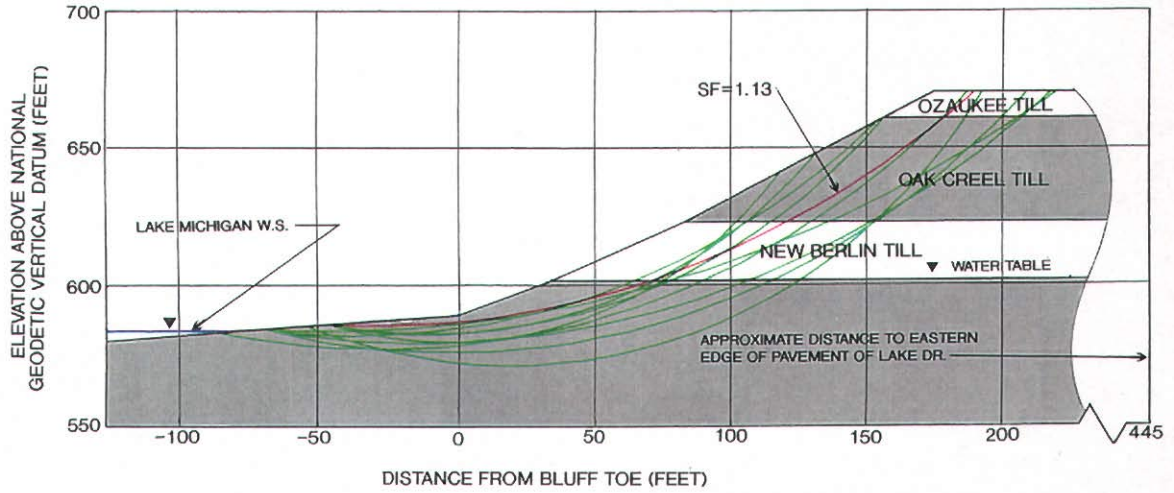
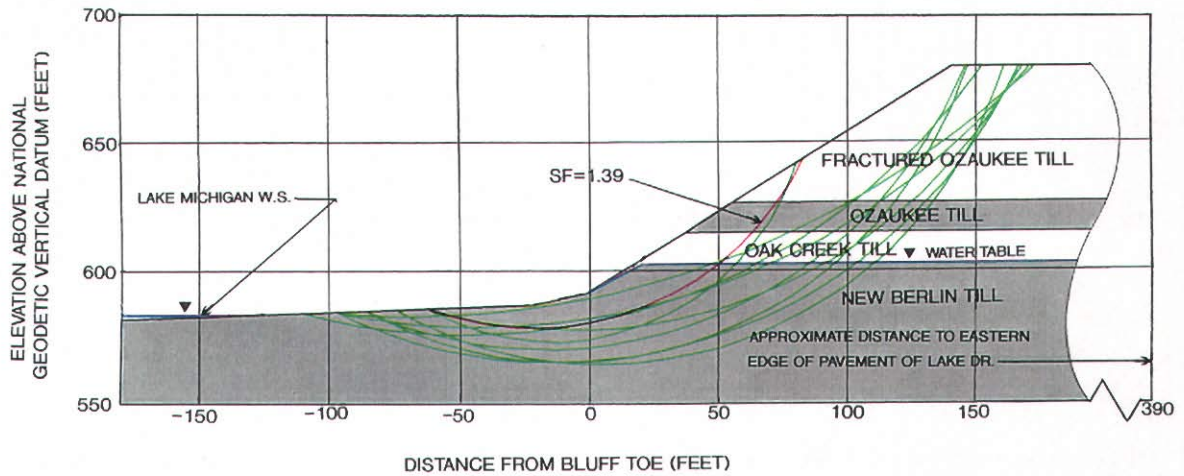
PROFILE 10-2
T.7N. R.22E. S.3

In 1995, two bluff profile field surveys were made within Erosion Zone 3a by occupying sites for which field surveys were conducted in 1976. The reoccupied sites had similar geometries to those documented in 1976, although the site at Profile No. 10-3 appeared to have become more steeply sloped. The stability of the bluff in Zone 3a of Reach 10 was characterized by Profile Nos. 10-2 and 10-3. Results of the slope stability analysis, shown in Figure 55, indicated that the bluff was stable in the zone, with safety factors of 1.13 at Profile No. 10-2 and 1.39 at Profile No. 10-3. The 1977 study reported bluff safety factors of 0.76 and 1.2 at Profile Nos. 10-2 and 10-3, respectively.

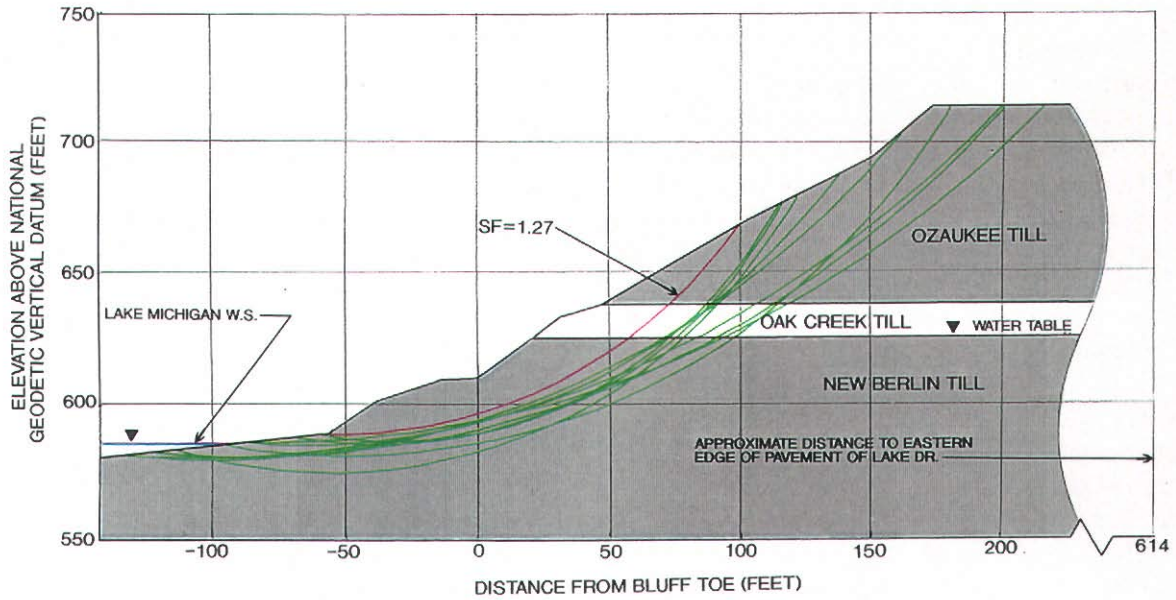
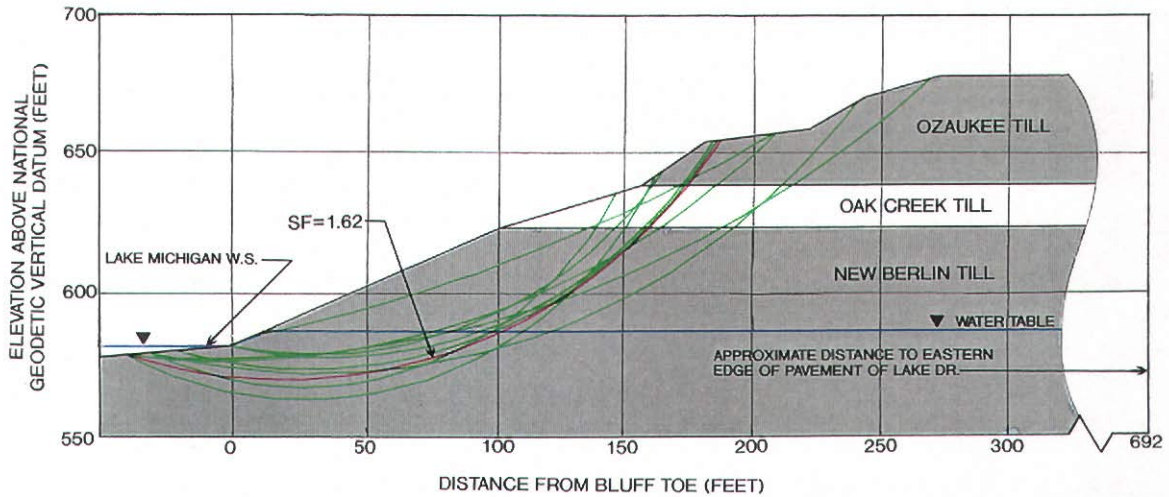
PROFILE 10-4

In 1995, two bluff profile field surveys were made within Erosion Zone 3b by occupying sites for which field surveys were conducted in 1976. The reoccupied sites had slightly different geometries to those documented in 1976, with a number of slope breaks being present during 1995 which were absent in 1976. The stability of the bluff in Zone 3b of Reach 10 was characterized by Profile Nos. 10-4 and 10-5. Results of the slope stability analysis, shown in Figure 56, indicated that the bluff was stable in the zone, with safety factors of 1.27 at Profile No. 10-4 and 1.62 at Profile No. 10-5. The 1977 study reported bluff safety factors of 0.69 and 0.46 at Profile Nos. 10-4 and 10-5, respectively.

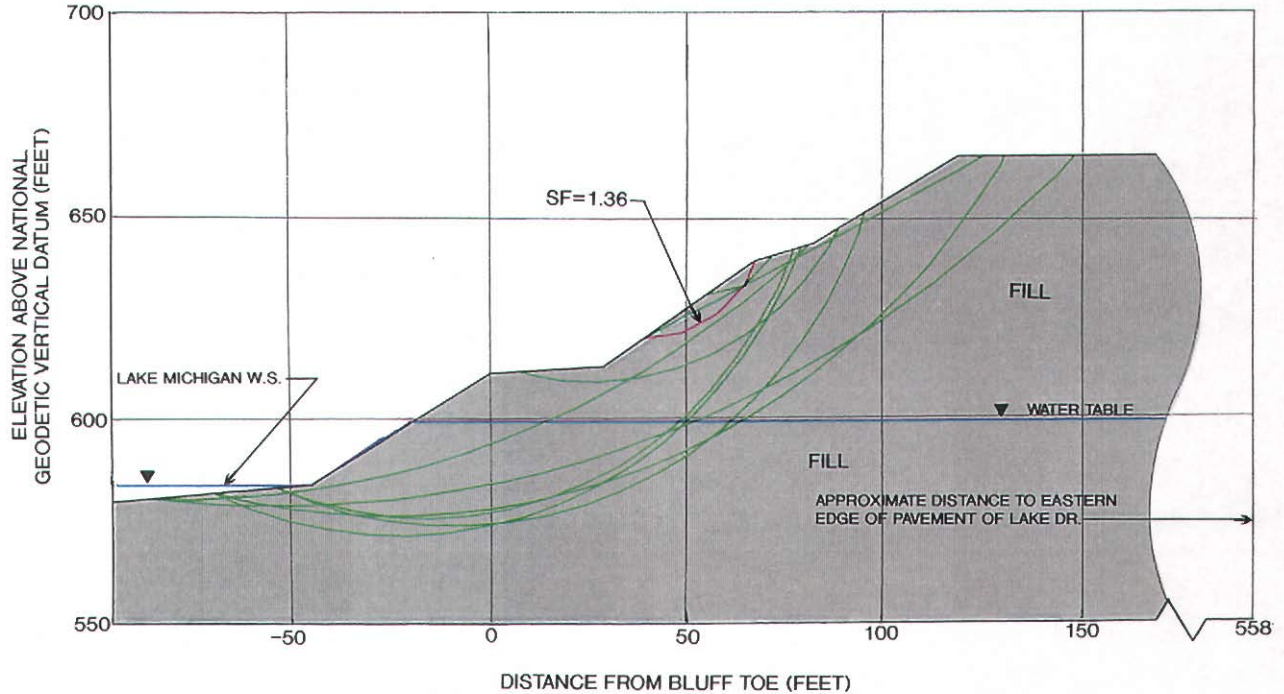
PROFILE 10-6
T.8N. R.22E. S.34

In 1995, three bluff profile field surveys were made within Sections 33 and 34 by occupying sites for which field surveys were conducted in 1976. At Profile Nos. 10-6 and 10-8, the sites had been significantly modified by regrading, and, at Profile No. 10-6, by the placement of rubble fill. At Profile No. 10-7, the site appeared to be slightly modified by regrading. The stability of the bluff in Sections 33 and 34 of Reach 10 was characterized by Profile Nos. 10-6 through 10-8. Results of the slope stability analyses, shown in Figures 57 and 58, indicated that the bluff was stable with respect to rotational failures, with safety factors of 1.26

at Profile Nos. 10-7 and 10-8, and, with a safety factor of 1.36 at Profile No. 10-6. However, 1995 field observations indicated that translational failures may occur. The 1977 study reported bluff safety factors at these sites of 0.46 to 1.0.

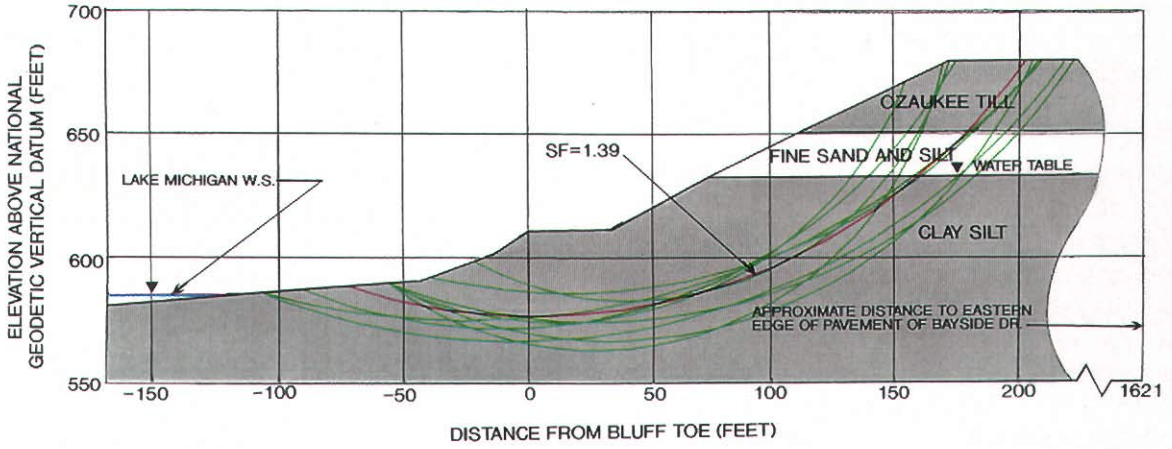
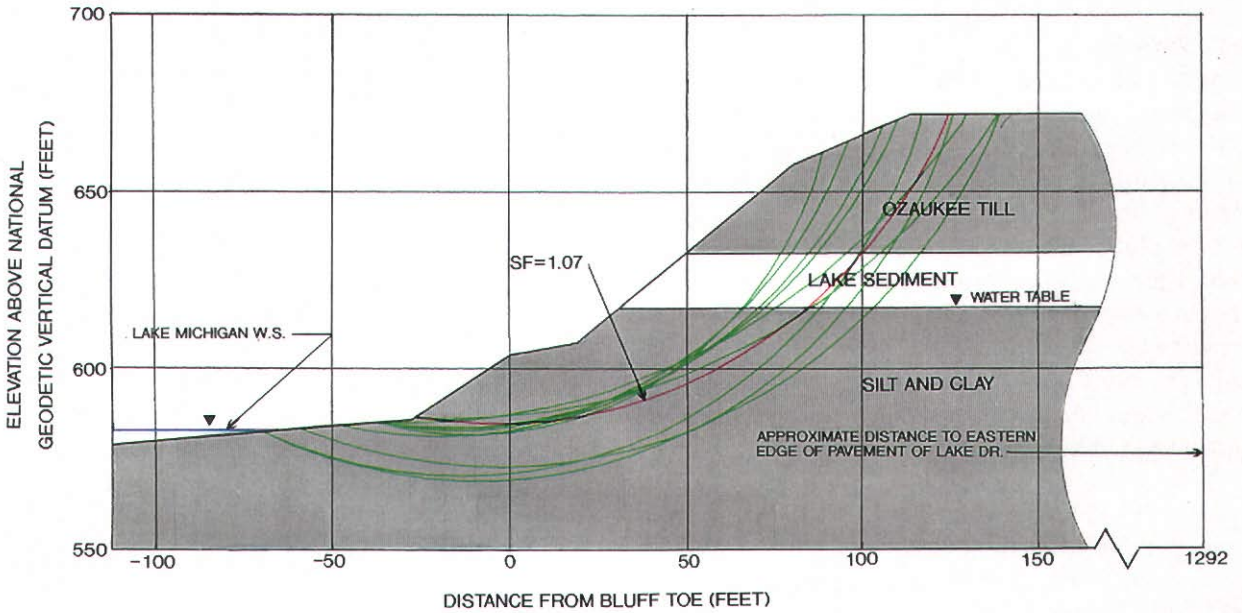
PROFILE 11-3

stability analysis, shown in Figure 63, indicated that the bluff was stable in the zone, with a safety factor of 1.39. The 1987 study reported a bluff safety factor of 1.71.

Profile No. 11-4. Results of the slope stability analysis, shown in Figure 63, indicated that the bluff was marginally stable in the zone with respect to rotational failures, with a safety factor of 1.07, based upon the deterministic bluff stability analysis method. Profile No. 11-4 was also analyzed using the probabilistic bluff stability analysis method which resulted in a range of safety factors from 0.71 to 1.5 for the 250 conditions considered. The analytical results indicated a safety factor of less than 1.0 for 16, or 64 percent, of the 25 critical conditions, as represented by the set of most critical conditions determined in each of the 25 analyses considered. In addition, a safety factor of less than 1.0 was determined for 149, or 59.6 percent, of the 250 conditions analyzed. Given the analytical results and the 1995 field observations, the bluffs were considered unstable with respect to both rotational and translational failures. The 1987 study reported a bluff safety factor of 0.85.

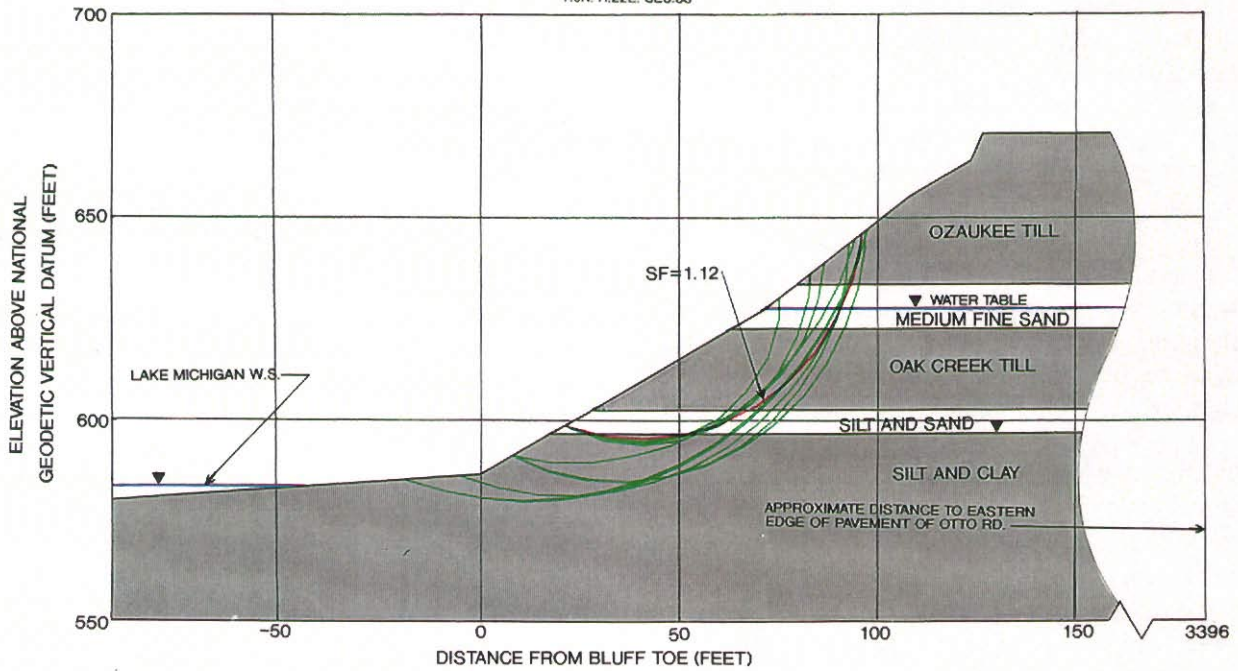
PROFILE 11-6
T.9N. R.22E. SEC.33

reported a bluff safety factor of 1.03 at Profile No. 11-6.

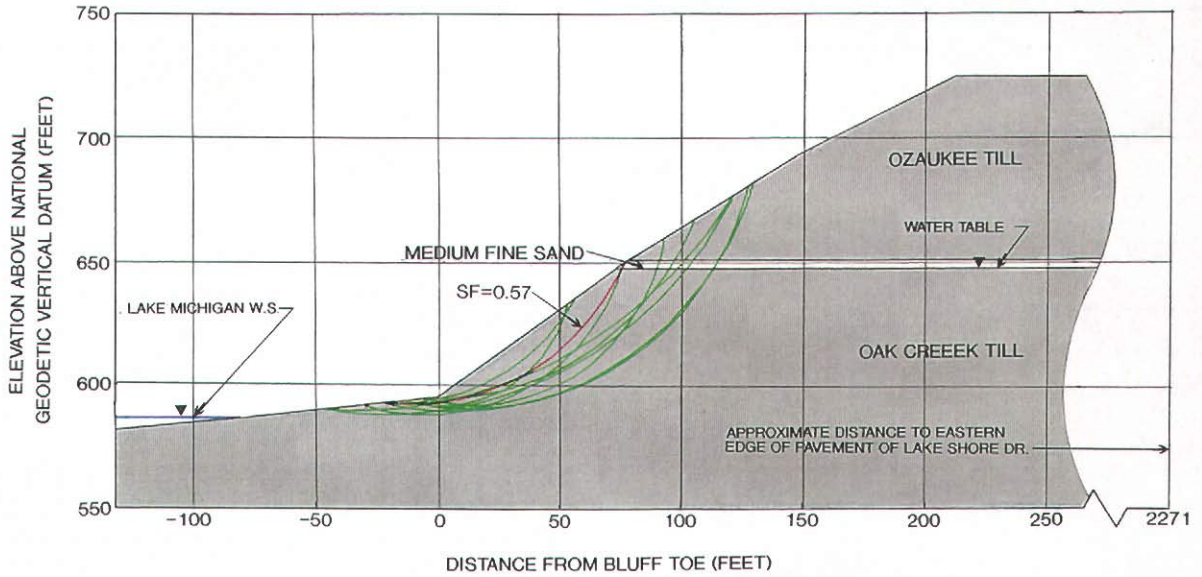
PROFILE 12-1
T.9N. R.22E. SEC.28

In 1995, one bluff profile field survey was made within Erosion Zone 28c by occupying a site for which a field survey was conducted in 1982. The stability of the bluff in Zone 28c of Reach 12 was characterized by Profile No. 12-1. Results of the slope stability analysis, shown in Figure 66, indicated that the bluff was unstable with respect to both rotational and translational failures, with a safety factor of 0.57. The 1977 study did not report a bluff safety factor.

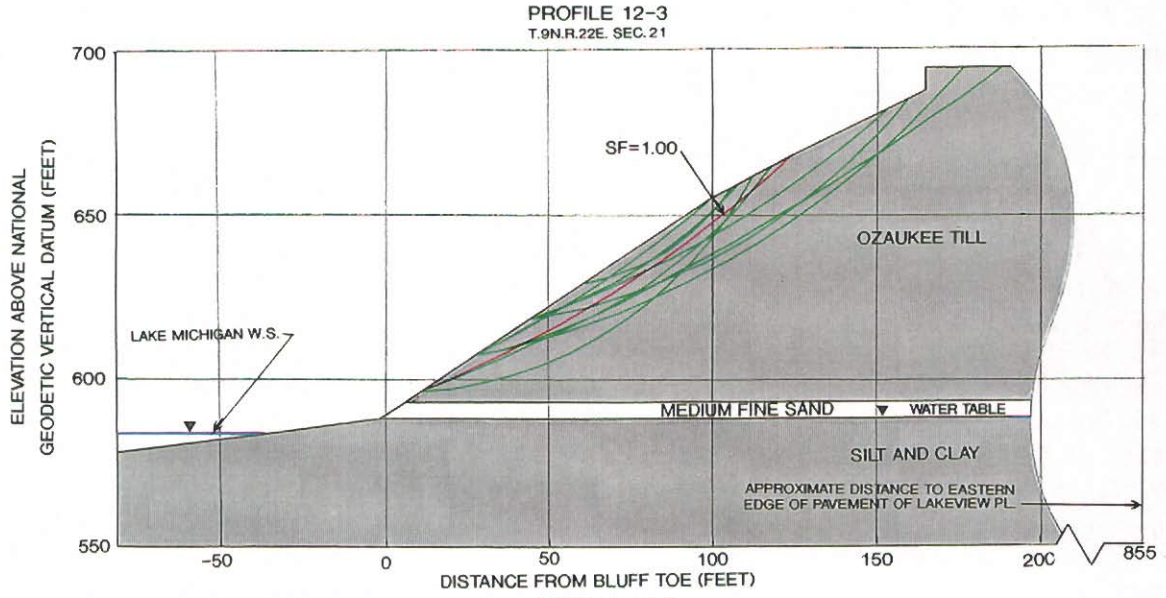
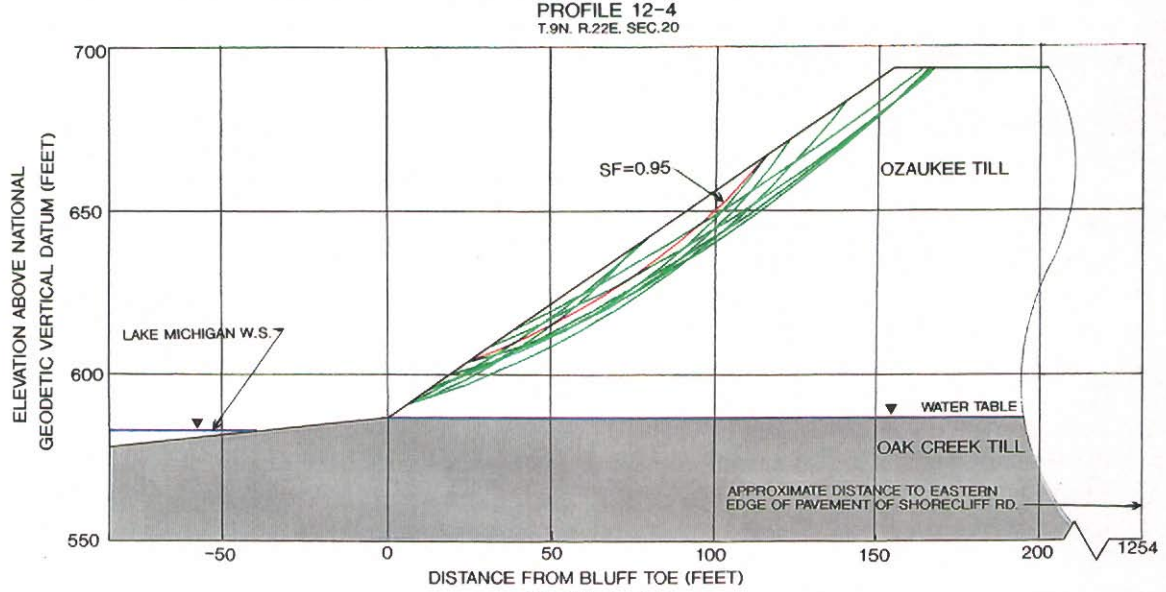
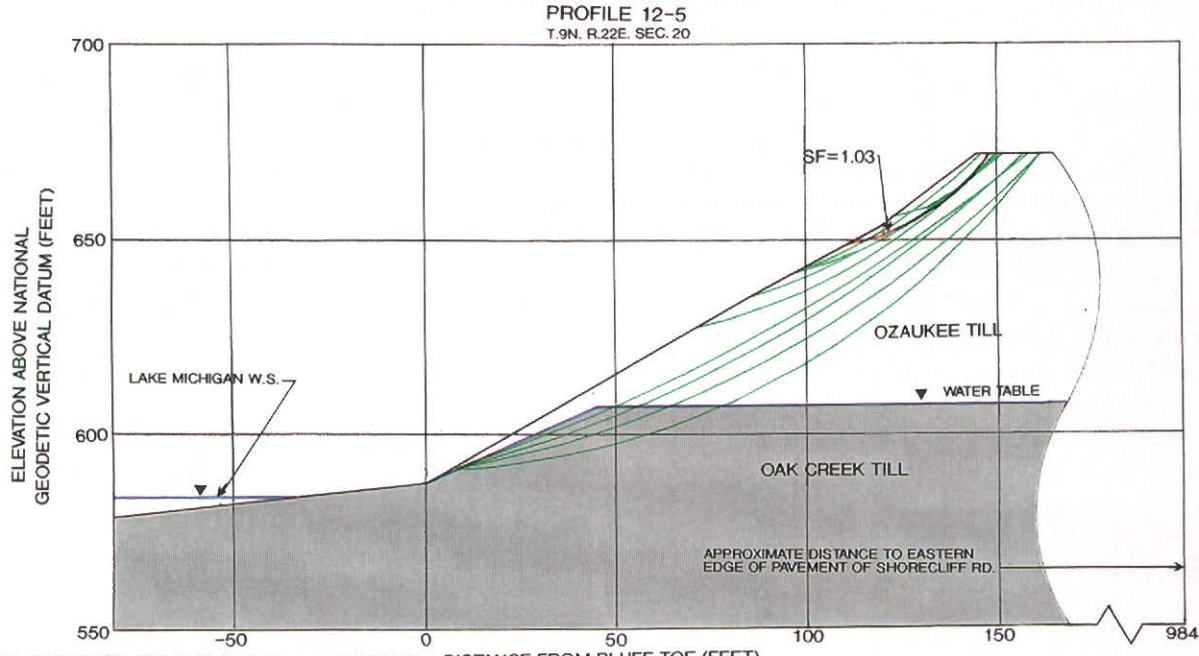
Figure 67
DETERMINISTIC BLUFF SLOPE STABILITY ANALYSES
 U.S. Public Land Survey Sections 20 and 21, Township 9 North, Range 22 East
 City of Mequon, Ozaukee County

In 1995, three profile field surveys were made within Zone 21a by occupying sites for which field surveys were conducted in 1976 and 1982. The stability of the bluff in Erosion Zone 21a was characterized by Profile Nos. 12-3 through 12-5. Results of the slope stability analysis, shown in Figure 67, indicated that the bluff was unstable to marginally stable with respect to rotational failures, with safety factors of 1.0 at Profile No. 12-3, 0.95 at Profile No. 12-4, and 1.03 at Profile No. 12-5, based upon the deterministic bluff stability analysis method. Profile Nos. 12-3 through 12-5 were also analyzed using the probabilistic bluff stability analysis method. At Profile No. 12-3, the probabilistic bluff stability analysis resulted in a range of safety factors from 0.88 to 1.4 for the 250 conditions considered. The analytical results indicated a safety factor of less than 1.0 for five, or 20 percent, of the 25 critical conditions, as represented by the set of most critical conditions determined in each of the 25 analyses considered. In addition, a safety factor of less than 1.0 was determined for 20, or 8 percent, of the 250 conditions analyzed. At Profile No. 12-4, the probabilistic bluff stability analysis resulted in a range of safety factors from 0.93 to 1.38 for the 250 conditions considered. The analytical results indicated a safety factor of less than 1.0 for six, or 24 percent, of the 25 critical conditions, as represented by the set of most critical conditions determined in each of the 25 analyses considered. In addition, a safety factor of less than 1.0 was determined for 34, or 13.6 percent, of the 250 conditions analyzed. At Profile No. 12-5, the

probabilistic bluff stability analysis resulted in a range of safety factors from 0.82 to 1.5 for the 250 conditions considered. The analytical results indicated a safety factor of less than 1.0 for five, or 20 percent, of the 25 critical conditions, as represented by the set of most critical conditions determined in each of the 25 analyses considered. In addition, a safety factor of less than 1.0 was determined for 32, or 12.8 percent, of the 250 conditions analyzed. Given the analytical results and the 1995 field observations, the bluffs were considered marginally stable to stable with respect to rotational failures. The 1995 field observations indicated that translational failures may occur. The 1977 study reported safety factors of 1.05 and 0.86 at Profile Nos. 12-3 and 12-5 from south to north within this zone. The 1982 study did not report a safety factor for Profile No. 12-4.

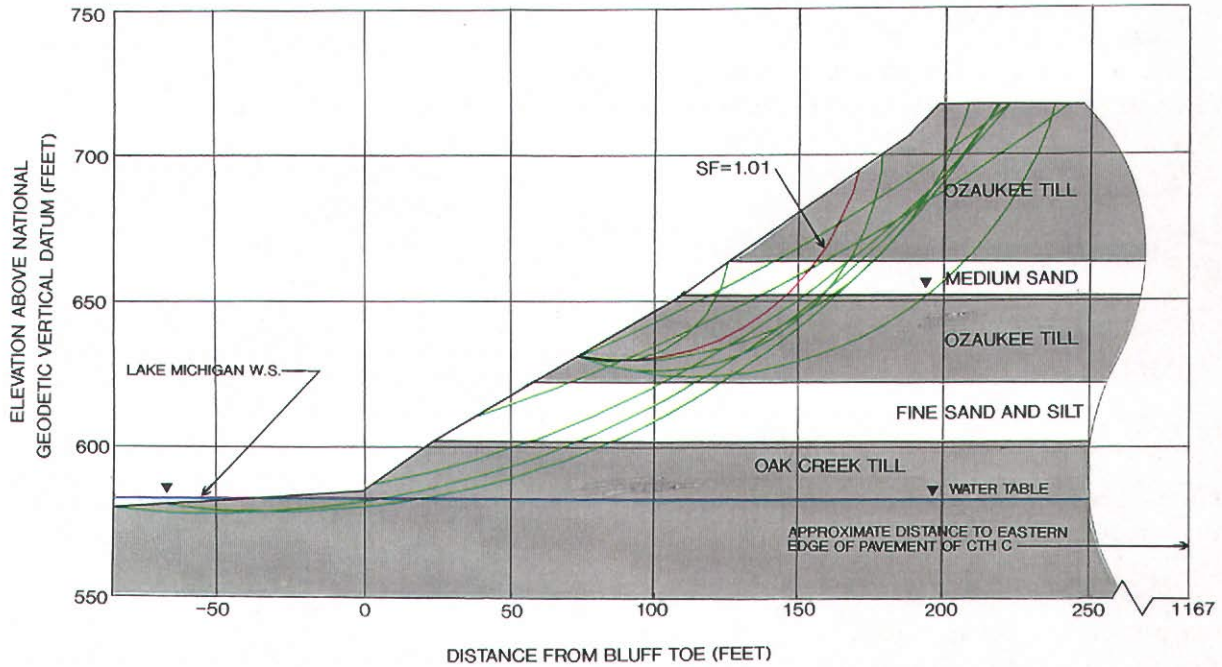
PROFILE 12-20
T.10N. R.22E. SEC.33

at Profile No. 12-19. The 1982 study did not report a safety factor at Profile No. 12-20.

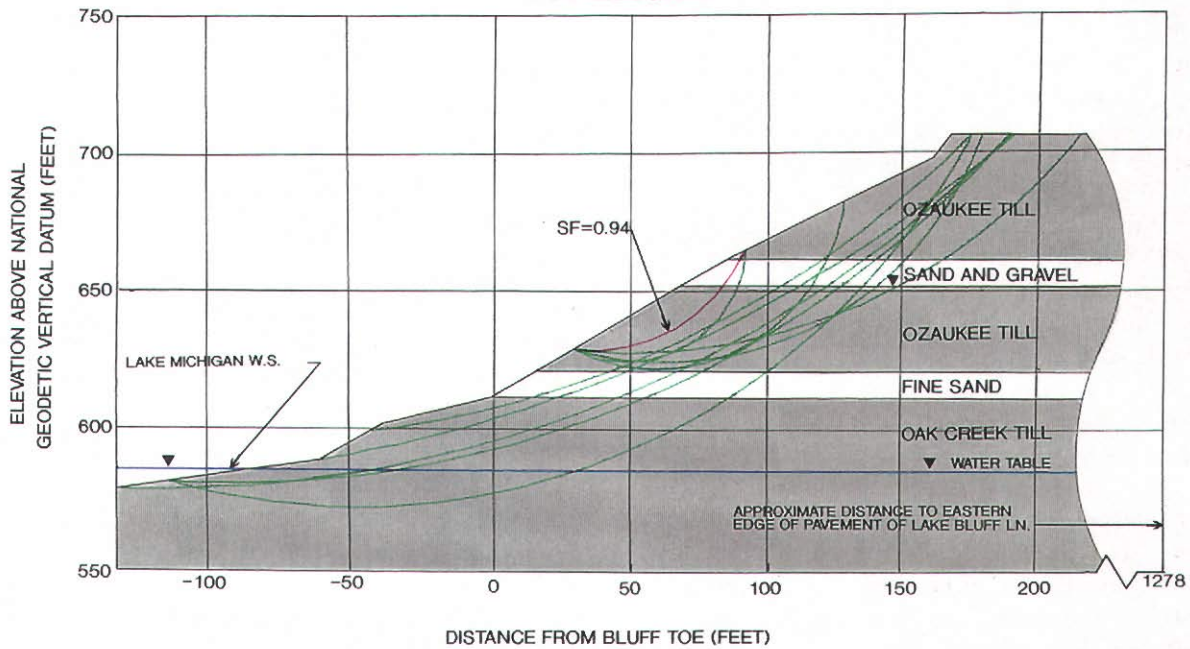
PROFILE 12-21
T.10N. R.22E. SEC.33

In 1995, one bluff profile field survey was made within Zone 33d, by reoccupying a site for which a field survey was conducted in 1976. The stability of the bluff in Erosion Zone 33d was characterized by Profile No. 12-21. Results of the slope stability analysis, shown in Figure 74, indicated that the bluff was unstable at Profile No. 12-21, with a safety factor of 0.94, based upon the deterministic bluff stability analysis. Profile No. 12-21 was also analyzed using the probabilistic bluff stability analysis method which resulted in a range of safety factors from 0.48 to 1.03 for the 250 conditions considered. The analytical results indicated a safety factor of less than 1.0 for 25, or 100 percent, of the 25 critical conditions, as represented by the set of most critical conditions determined in each of the 25 analyses considered. In addition, a safety factor of less than 1.0 was determined for 247, or 98.8 percent, of the 250 conditions analyzed. Given the analytical results and the 1995 field observations, the bluff was considered unstable with respect to both rotational and translational failures. The 1977 study reported a safety factor of 0.92.

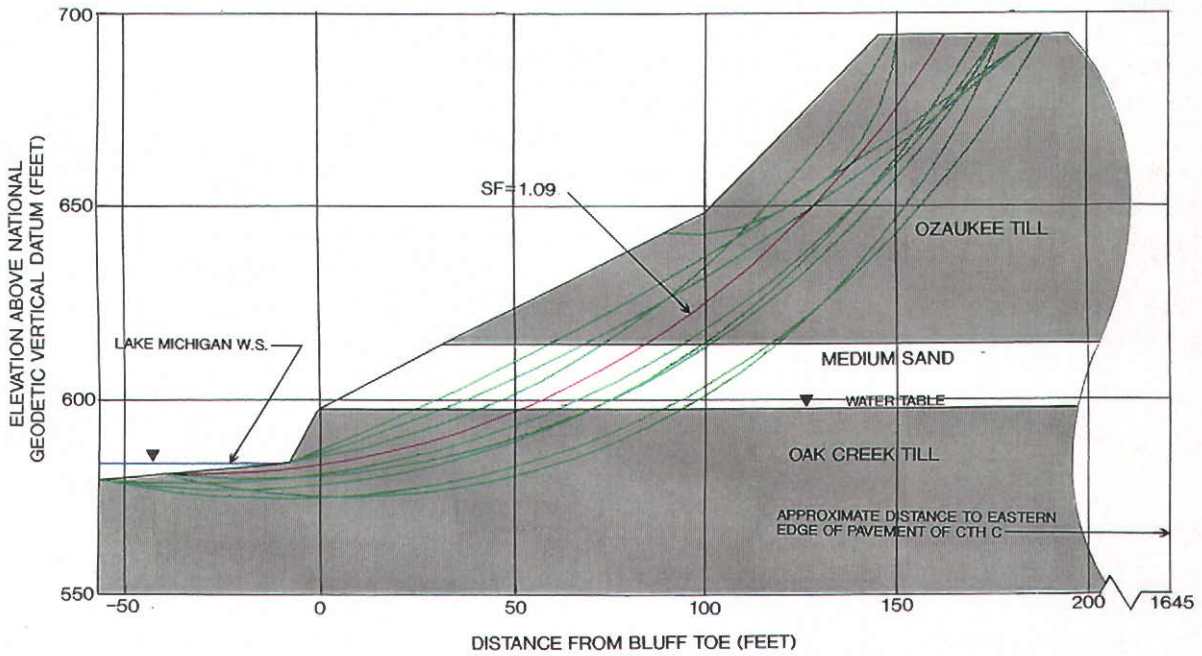
PROFILE 12-25

In 1995, one bluff profile field survey was made within Erosion Zone 28e by occupying a site for which a field survey was conducted in 1982. The stability of the bluff in Zone 28e of Reach 12 was characterized by Profile No. 12-25. Results of the slope stability analysis, shown in Figure 76, indicated that the bluff was marginally stable in the zone with respect to rotational failures, with a safety factor of 1.09, based upon the deterministic bluff stability analysis method. Profile No. 12-25 was also analyzed using the probabilistic bluff stability analysis method which resulted in a range of safety factors from 0.88 to 1.26 for the 250 conditions considered. The analytical results indicated a safety factor of less than 1.0 for seven, or 28 percent, of the 25 critical conditions, as represented by the set of most critical conditions determined in each of the 25 analyses considered. In addition, a safety factor of less than 1.0 was determined for 55, or 22 percent, of the 250 conditions analyzed. Given the analytical results and the 1995 field observations, the bluffs were considered marginally stable with respect to both rotational and translational failures. The 1977 study did not report a bluff safety factor for this zone.

In 1995, evidence of active shoreline erosion was observed on the bluff slopes within Erosion Zone 28e. It appeared that major slumps could occur during future periods of higher lake levels.

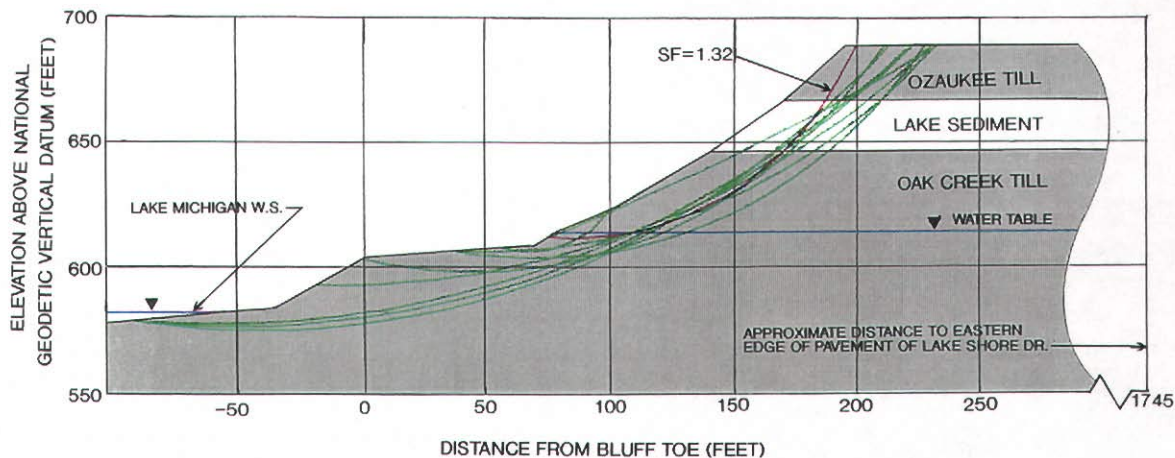
PROFILE 13-1

Erosion Zone 21b extends from the northerly limits of Erosion Zone 21a north about 0.08 mile, as shown on Map 75. This zone had a very narrow to nonexistent beach. In 1995, an existing slump block, reported in the 1977 study as being about halfway up the slope of the bluff, appeared to have moved further down the bluff slope to the lower part of the slope. The 1995 field observations indicated that it was probable that this block would continue to move in the future, and that small en-echelon failures would form at the bluff top. In 1995, the bluff was noted to be about 30 percent vegetated.

In 1995, one bluff profile field survey was made within Zone 21b by occupying a site for which a field survey was conducted in 1976. The stability of the bluff in Erosion Zone 21b was characterized by Profile No. 13-1. Results of the slope stability analysis, shown in Figure 77, indicated that the bluff was stable with respect to rotational failures within this zone, with a safety factor of 1.32, based upon the deterministic bluff stability analysis. However, 1995 field observations indicated that translational failures may occur. The 1977 study reported a safety factor 0.59 at the toe of the bluff.

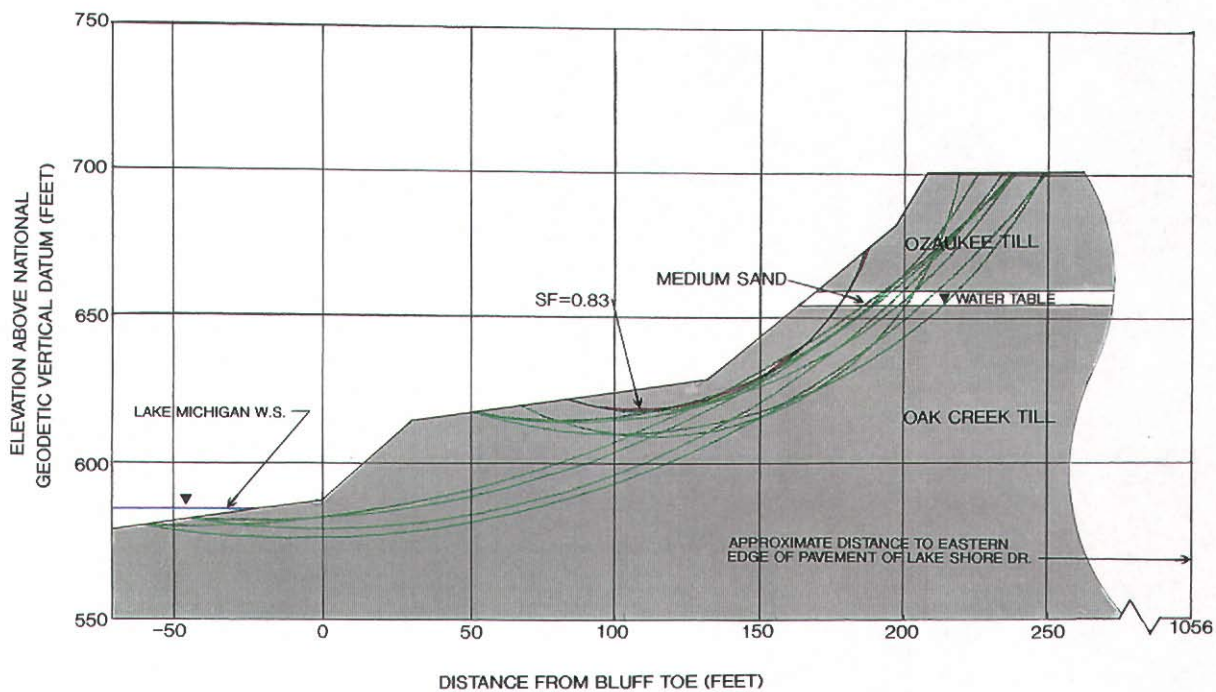
PROFILE 13-2

1976, with the exception of several masses dropping about halfway down the bluff. About 0.3 mile into Zone 21c, a deep-seated failure was noted to have taken place, with at least 20 feet of the bluff top observed to have been lost in 1995. In addition, en-echelon failures were noted to be occurring near the bluff top.

In 1995, one bluff profile field survey was made within Zone 21c by occupying a site for which a field survey was conducted in 1976. The bluff material at this site was estimated to be till interbedded with sand. The stability of the bluff in Erosion Zone 21c was characterized by Profile No. 13-2. Results of the slope stability analysis, shown in Figure 77, indicated that the bluff was unstable with respect to both rotational and translational failures, with a safety factor of 0.83, based upon the deterministic bluff stability analysis. The 1977 study reported a safety factor of 0.82 for the top of the bluff.

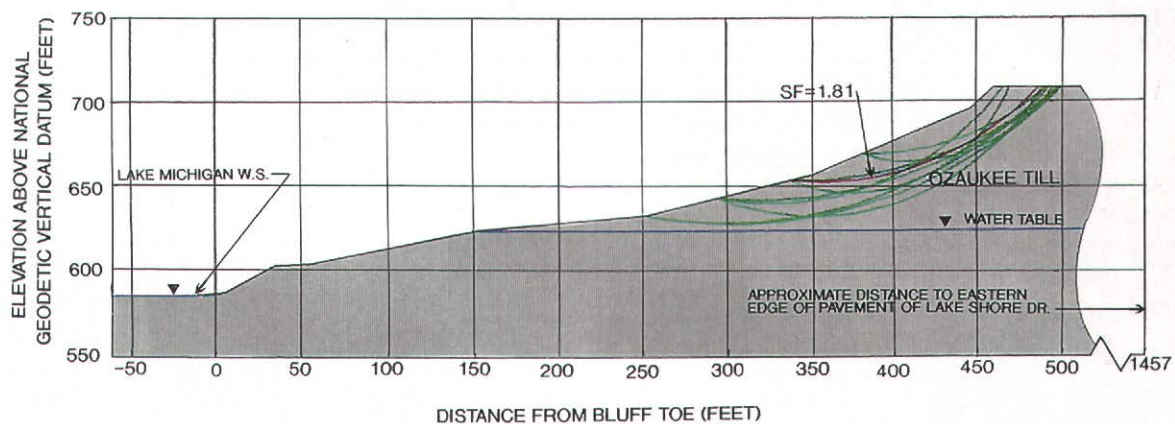
PROFILE 13-3
T.10N. R.22E. SEC.21

In 1995, one bluff profile field survey was made within Zone 21e by occupying a site for which a field survey was conducted in 1976. The stability of the bluff in Erosion Zone 21e was characterized by Profile No. 13-3. Results of the slope stability analysis, shown in Figure 78, indicated that the bluff was stable with respect to rotational failures, with a safety factor of 1.81, based upon the deterministic bluff stability analysis. The 1977 study reported a safety factor of 0.75 for the toe of the bluff.

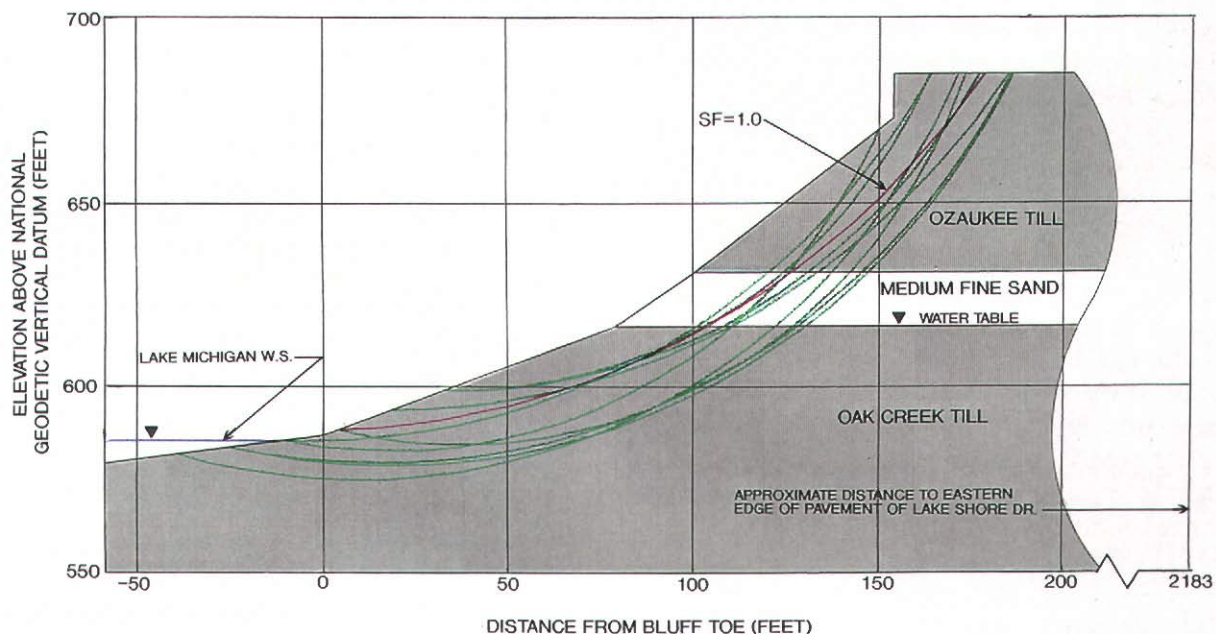
PROFILE 13-4
T.10N. R.22E. SEC.16

Erosion Zone 16a extends from the south line of Section 16 north 0.7 mile, as shown on Map 76. The beach in this zone ranged from being nonexistent to 20 feet in width. In 1995, the bluff in this had height of about 100 feet. The bluff was noted to be 80 to 90 percent vegetated. The southern part of the bluff was vegetated mostly by northern white cedar and the northern part by shrubs and grass-like vegetation. The 1995 field observations indicated that the lower part of the bluff was protected by old slump blocks which were eroding along much of the beach.

In 1995, one bluff profile field survey was made within Zone 16a by occupying a site for which a field survey was conducted in 1976. The stability of the bluff in Erosion Zone 16a was characterized by Profile No. 13-4. Results of the slope stability analysis, shown in Figure 78, indicated that the bluff was marginally stable, with a safety factor of 1.0, based upon the deterministic bluff stability analysis. Profile No. 13-4 was also analyzed using the probabilistic bluff stability analysis method which resulted in a range of safety factors from 0.79 to 1.44 for the 250 conditions considered. The analytical results indicated a safety factor of less than 1.0 for seven, or 28 percent, of the 25 critical conditions, as represented by the set of most critical conditions determined in each of the 25 analyses considered. In addition, a safety factor of less than 1.0 was determined for 39, or 15.6 percent, of the 250 conditions analyzed. Given the analytical results and the 1995 field observations, the bluffs were considered marginally stable with respect to both rotational and translational

failures. The 1977 study reported a safety factor of 0.59 for the upper slope of the bluff.

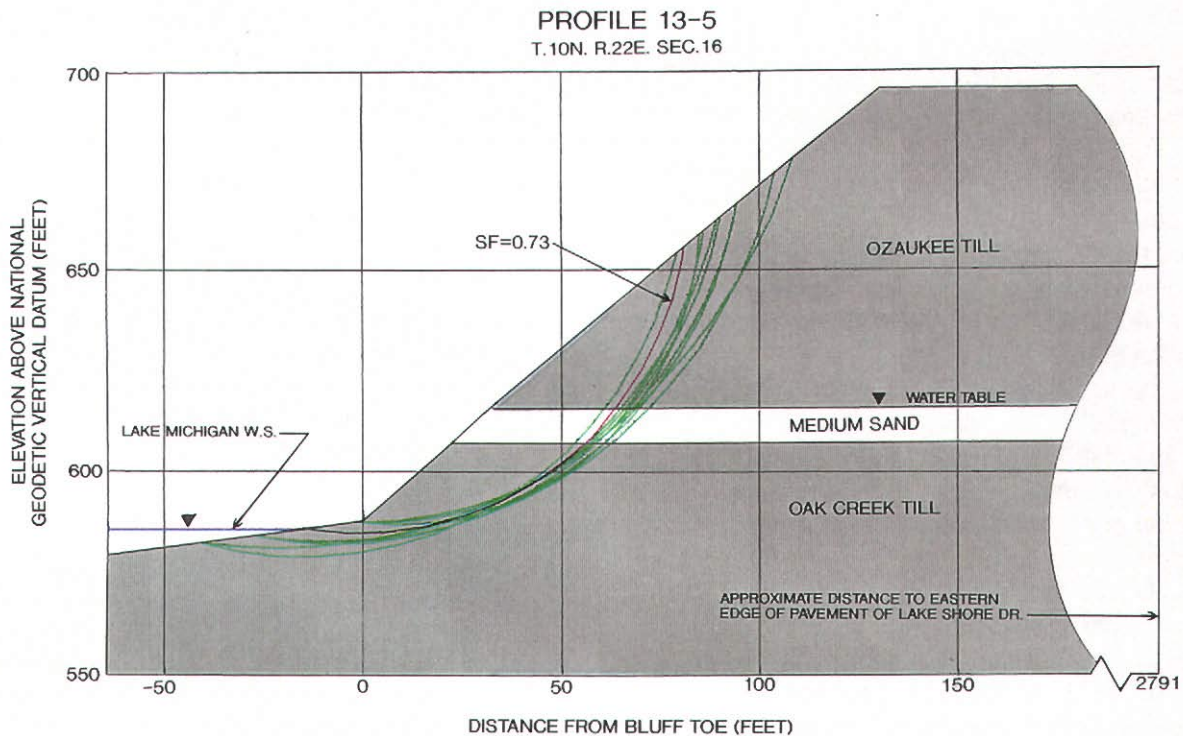
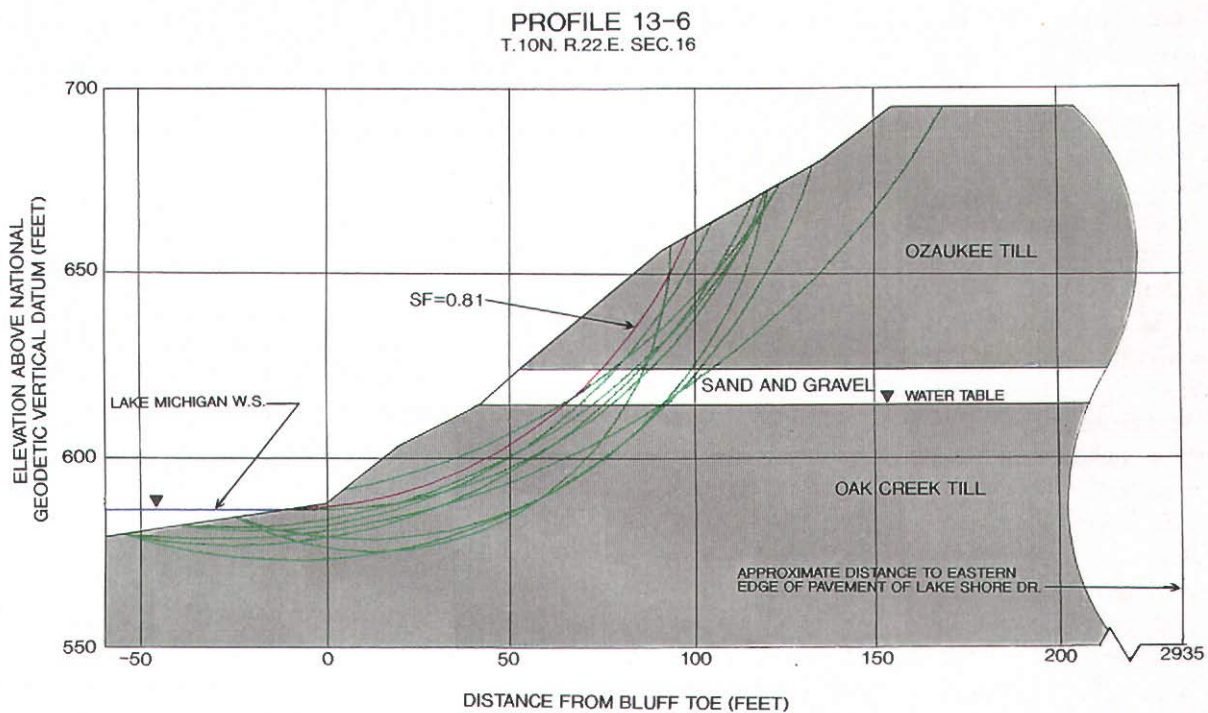
In 1995, two bluff profile field surveys were made within Zone 16b by occupying sites for which field surveys were conducted in 1976 and in 1982. The stability of the bluff in Erosion Zone 16b was characterized by Profile Nos. 13-5 and 13-6. Results of the slope stability analyses, shown in Figure 79, indicated that the bluff was unstable with respect to both rotational and translational failures, with a safety factor of 0.73 at Profile No. 13-5 and a safety factor of 0.81 at Profile No. 13-6, based upon the deterministic bluff stability analysis. The 1977 study reported a safety factor of 0.65 at Profile No. 13-5. The 1982 study did not report a bluff safety factor at Profile No. 13-6.
