LAKE MICHIGAN SHORELINE RECESSION AND BLUFF STABILITY IN SOUTHEASTERN WISCONSIN: 1995

TECHNICAL REPORT
NUMBER 36

**LAKE MICHIGAN SHORELINE RECESSION AND
BLUFF STABILITY IN SOUTHEASTERN WISCONSIN: 1995**

Southeastern Wisconsin Regional Planning Commission

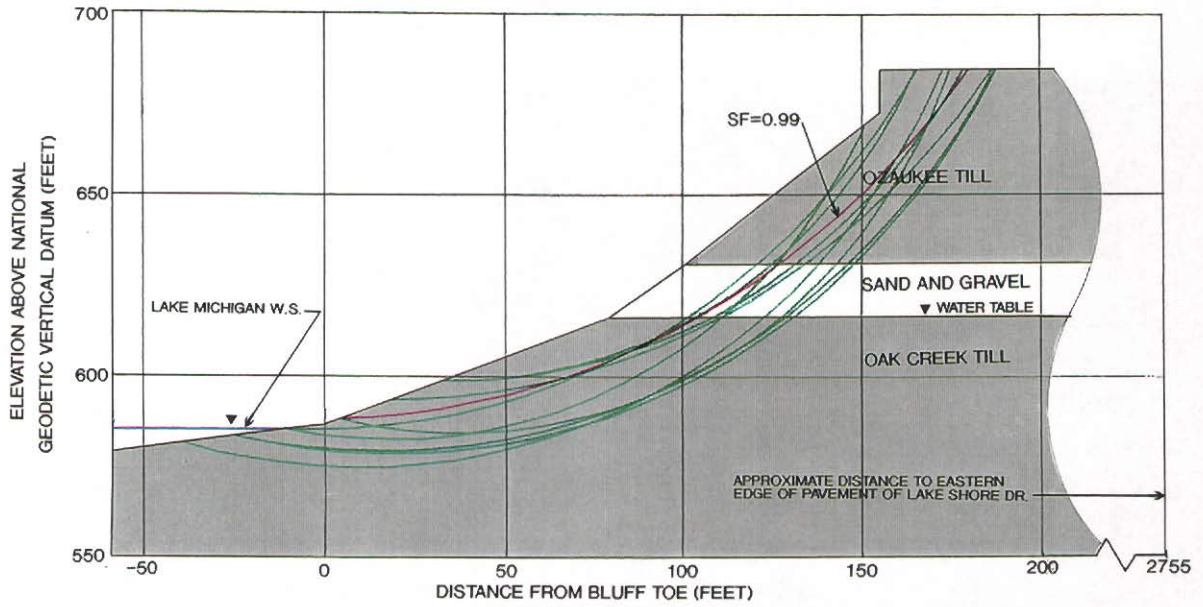
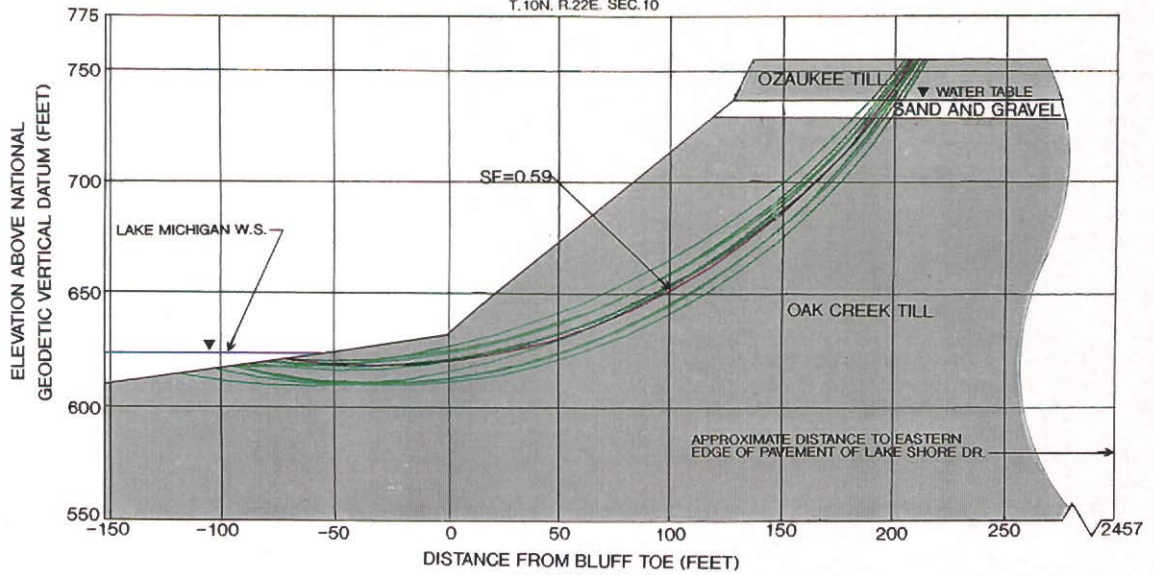
in Erosion Zone 10a was characterized by Profile Nos. 13-7 and 13-8. Results of the slope stability analyses, shown in Figure 80, indicated that the bluff was unstable, with a safety factor of 0.99 at Profile No. 13-7 and a safety factor of 0.59 at Profile No. 13-8, based upon the deterministic bluff stability analysis. Profile No. 13-7 was also analyzed using the probabilistic bluff stability analysis method which resulted in a range of safety factors from 0.78 to 1.17 for the 250 conditions considered. The analytical results indicated a safety factor of less than 1.0 for 13, or 52 percent, of the 25 critical conditions, as represented by the set of most critical conditions determined in each of the 25 analyses considered. In addition, a safety factor of less than 1.0 was determined for 116, or 46.4 percent, of the 250 conditions analyzed. Given the analytical results and the 1995 field observations, the bluff was considered marginally stable with respect to both rotational and translational failures. The 1977 study reported a safety factor of 0.59 at Profile No. 13-7.

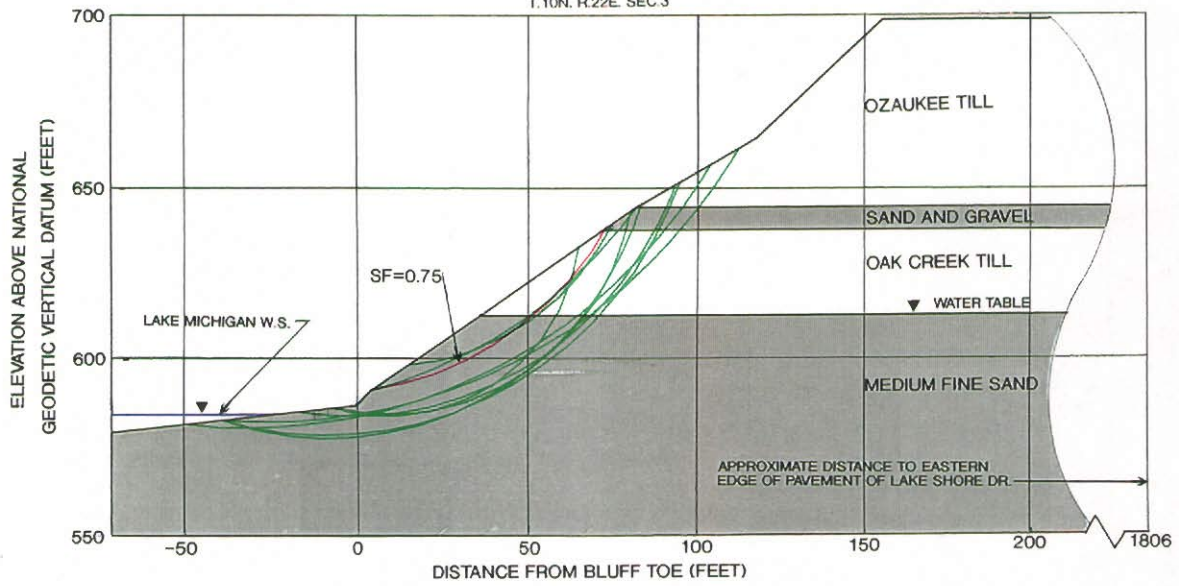
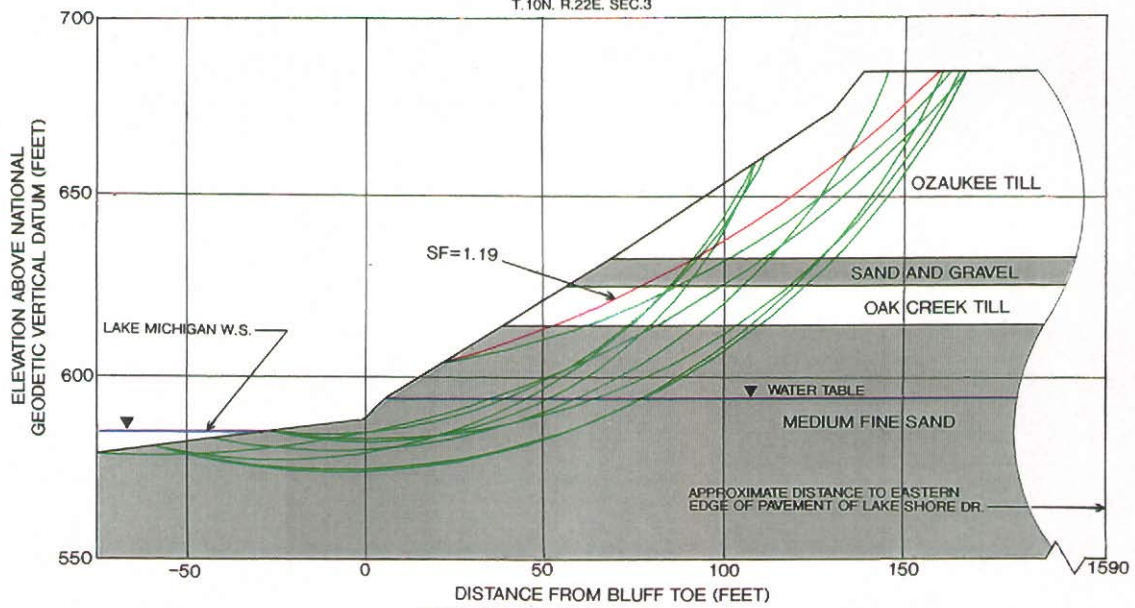
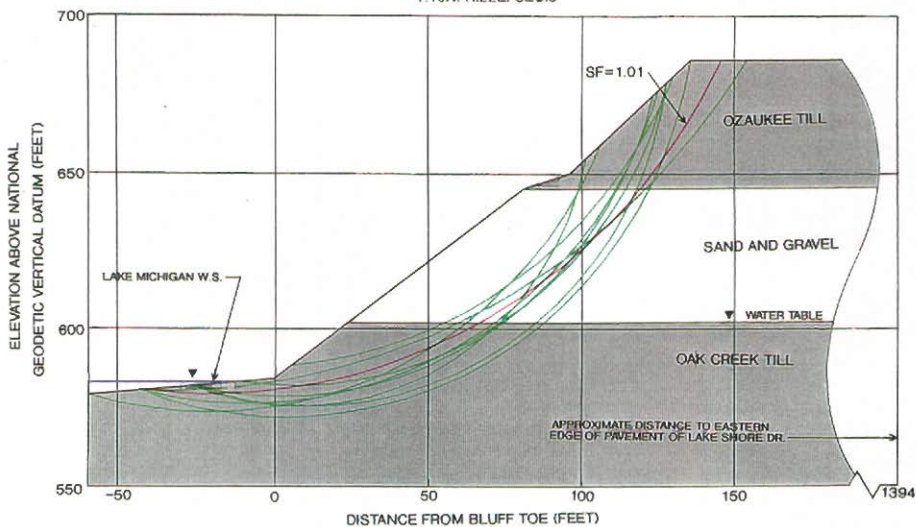
In 1995, five bluff profile field surveys were made within Section 3. Three of these profiles occupied sites for which field surveys were conducted in 1976 and the other two profiles occupied sites for which field surveys were conducted in 1982. The stability of the bluff in Section 3 was characterized by Profile Nos. 13-10 through 13-14. Results of the slope stability analyses, shown in Figures 81 and 82, indicated that the bluff was unstable to marginally stable with respect to rotational failures throughout the southern and northern portions of the section, with safety factors ranging between 0.75 and 1.03, based upon the deterministic bluff stability analysis. The bluff at Profile No. 13-11 in the south-central portion of the section was stable, with a safety factor of 1.19, based upon the deterministic bluff stability analysis. Profile Nos. 13-12 and 13-13 were also analyzed using the probabilistic bluff stability analysis method. At Profile No. 13-12, the probabilistic bluff stability analysis resulted in a range of safety factors from 0.87 to 1.24 for the 250 conditions considered. The analytical results indicated a safety factor of less than 1.0 for 14, or 56 percent, of the 25 critical conditions, as represented by the set of most critical conditions determined

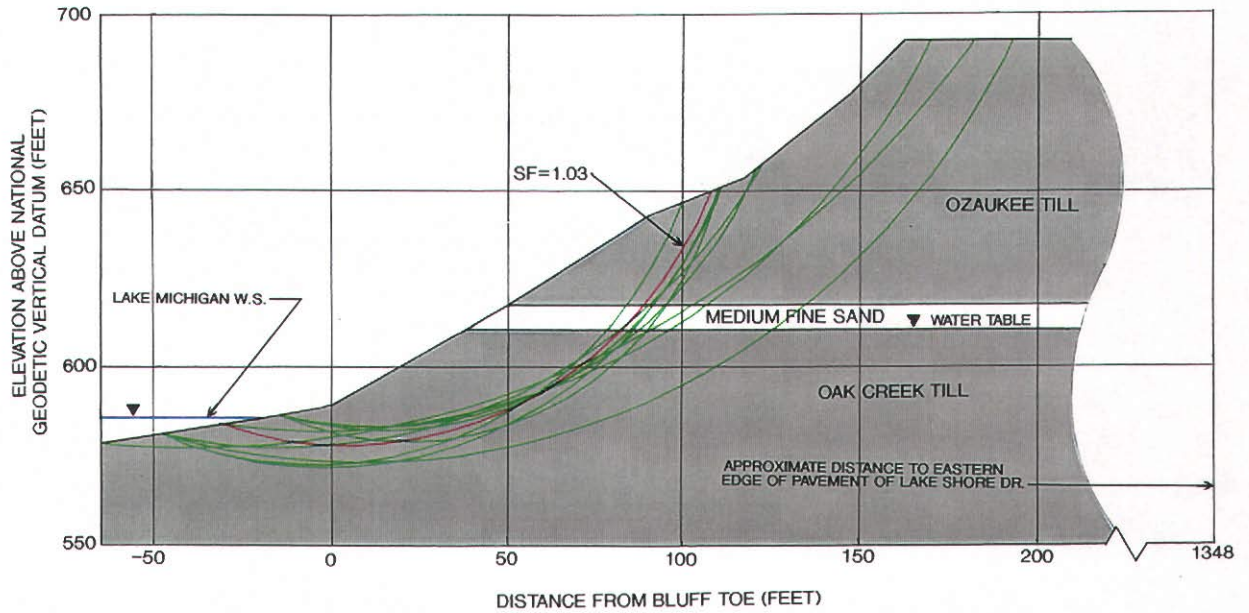
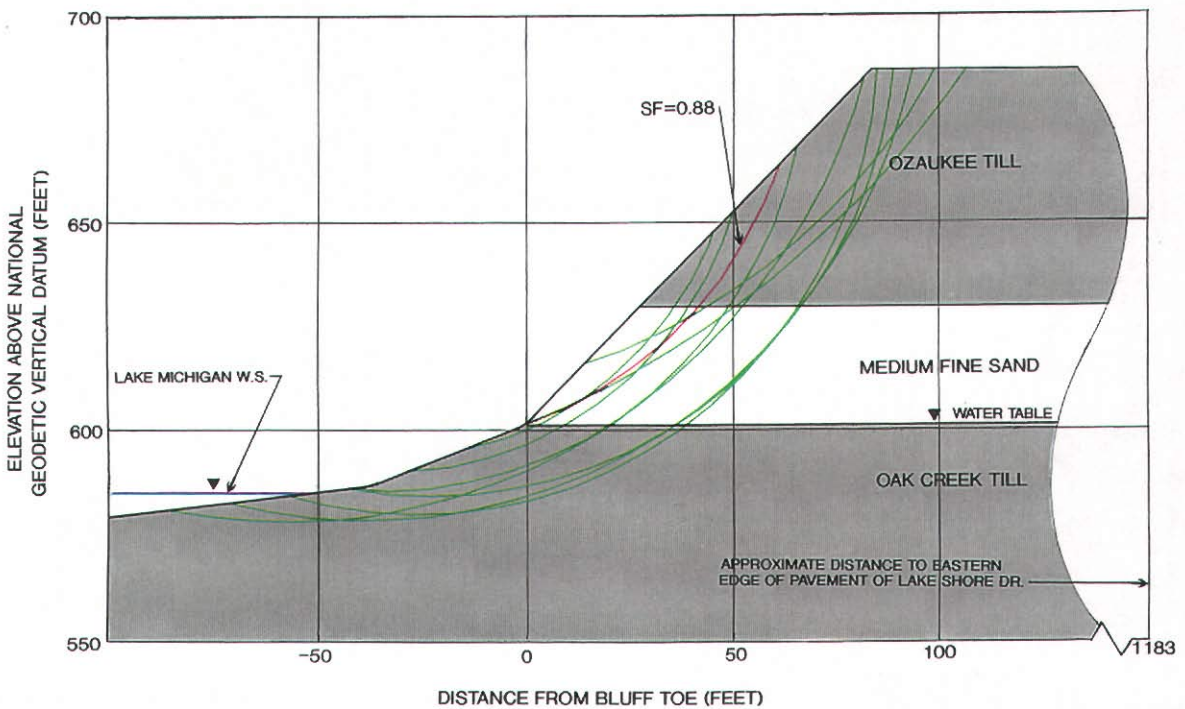
Figure 82

in each of the 25 analyses considered. In addition, a safety factor of less than 1.0 was determined for 97, or 38.8 percent, of the 250 conditions analyzed. At Profile No. 13-13, the probabilistic bluff stability analysis resulted in a range of safety factors from 0.84 to 1.2 for the 250 conditions considered. The analytical results indicated a safety factor of less than 1.0 for 13, or 52 percent, of the 25 critical conditions, as represented by the set of most critical conditions determined in each of the 25 analyses considered. In addition, a safety factor of less than 1.0 was determined for 62, or 24.8 percent, of the 250 conditions analyzed. Given the analytical results and the 1995 field observations, the bluffs were considered marginally stable with respect to both rotational and translational failures. The 1977 study reported safety factors ranging between 0.49 and 0.51. The 1982 study did not report bluff safety factors at these sites.

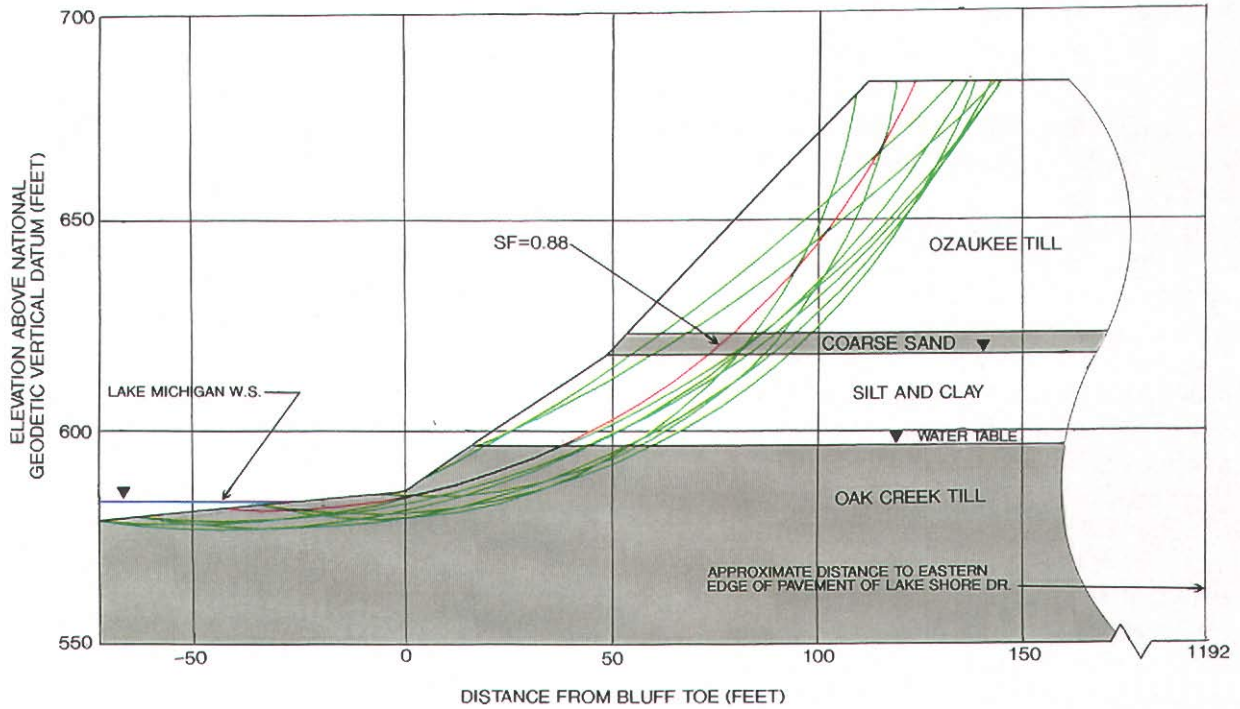
PROFILE 13-15
T.11N. R.22E. SEC.33

In 1995, one bluff profile field survey was made within Zone 33a by occupying a site for which a field survey was conducted in 1976. The stability of the bluff in Erosion Zone 33a was characterized by Profile No. 13-15. Results of the slope stability analyses, shown in Figure 83, indicated that the bluff was unstable with respect to both rotational and translational failures, with a safety factor of 0.88, based upon the deterministic bluff stability analysis. The 1977 study reported a safety factor of 0.62.

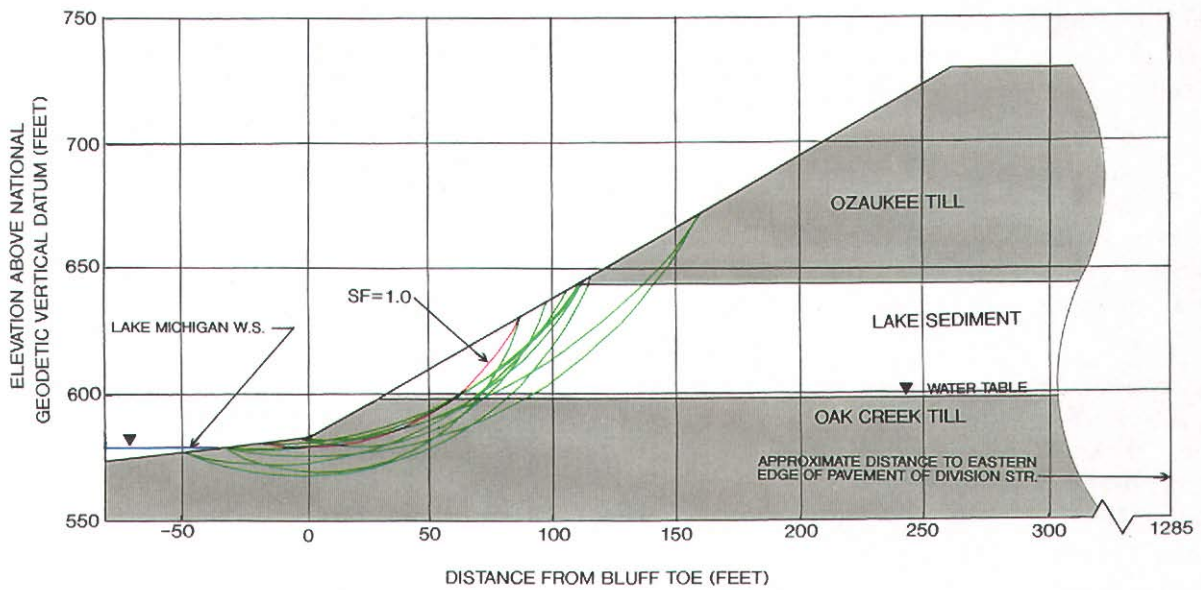
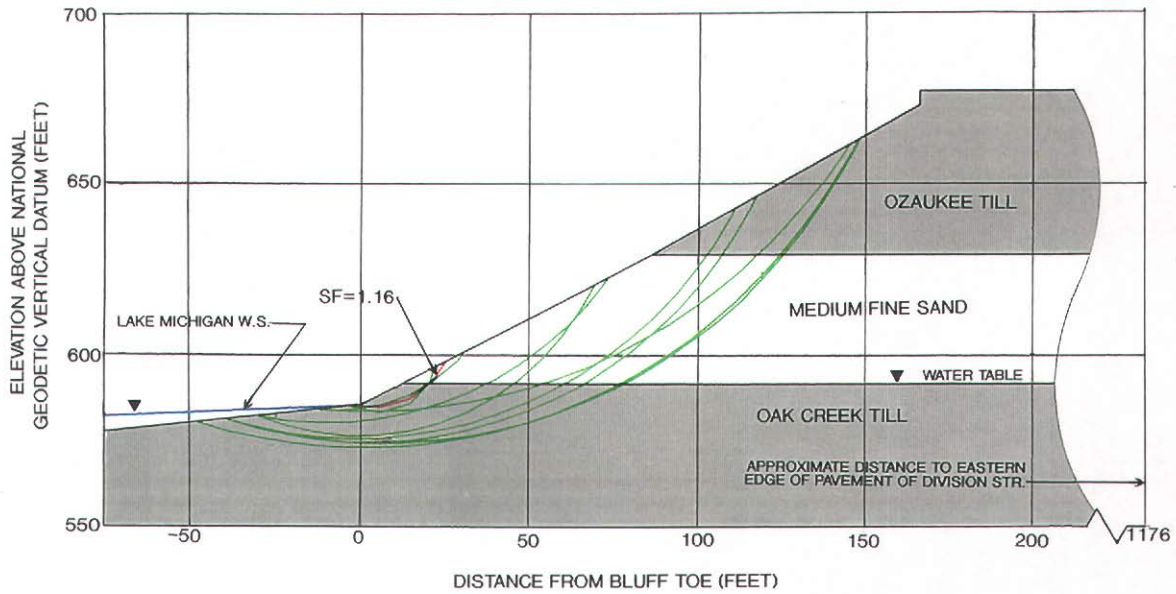
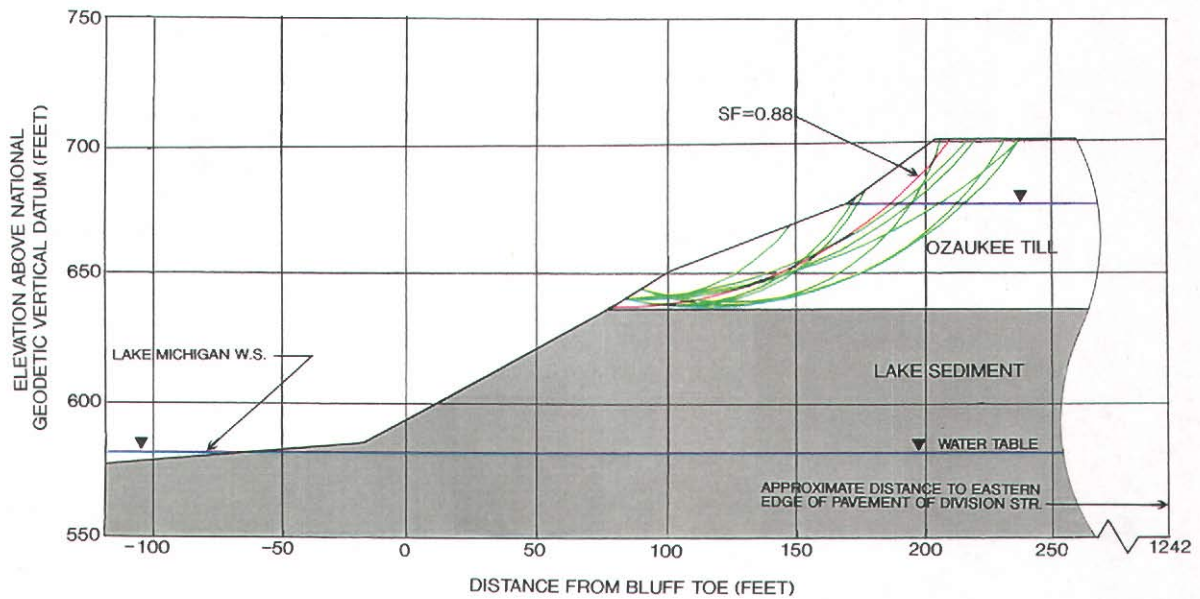
Erosion Zone 33b extends from the northerly limit of Erosion Zone 33a north to the north line of Section 33, as shown on Map 79. The entire shoreline of this zone was occupied by the City of Port Washington Power Plant. This zone had a beach of between 10 and 50 feet in width. The bluff in this zone was noted to be about 60 percent vegetated in 1995. The 1995 field observations indicated that some recent failures had taken place, and signs of small, shallow slides were present.

In 1995, three bluff profile field surveys were made within Zone 33b by occupying sites for which field surveys were conducted in 1976 and 1982. The stability of the bluff in Erosion Zone 33b was characterized by Profile Nos. 13-16 through 13-18. Results of the slope stability analyses, shown in Figures 83 and 84, indicated that the bluff was marginally stable, with a safety factor of 1.0 at Profile No. 13-16; stable, with a safety factor of 1.16 at Profile No. 13-17; and unstable, with a safety factor of 0.88 at Profile No. 13-18, based upon the deterministic bluff stability analysis. Profile No. 13-16 was also analyzed using the probabilistic bluff stability analysis method which resulted in a range of safety factors from 0.88 to 1.38 for the 250 conditions considered. The analytical results indicated a safety factor of less than 1.0 for eight, or 32 percent, of the 25 critical conditions, as represented by the set of most critical conditions determined in each of the 25 analyses considered. In addition, a safety factor of less than 1.0 was determined for 13, or 5.2 percent, of the 250 conditions analyzed. Given the analytical results and the 1995 field observations, the bluffs were considered marginally stable with respect to both rotational and translational failures. The 1977 study reported a safety factor of 0.81 at Profile No. 13-17. The 1982 study did not report a bluff safety factor.

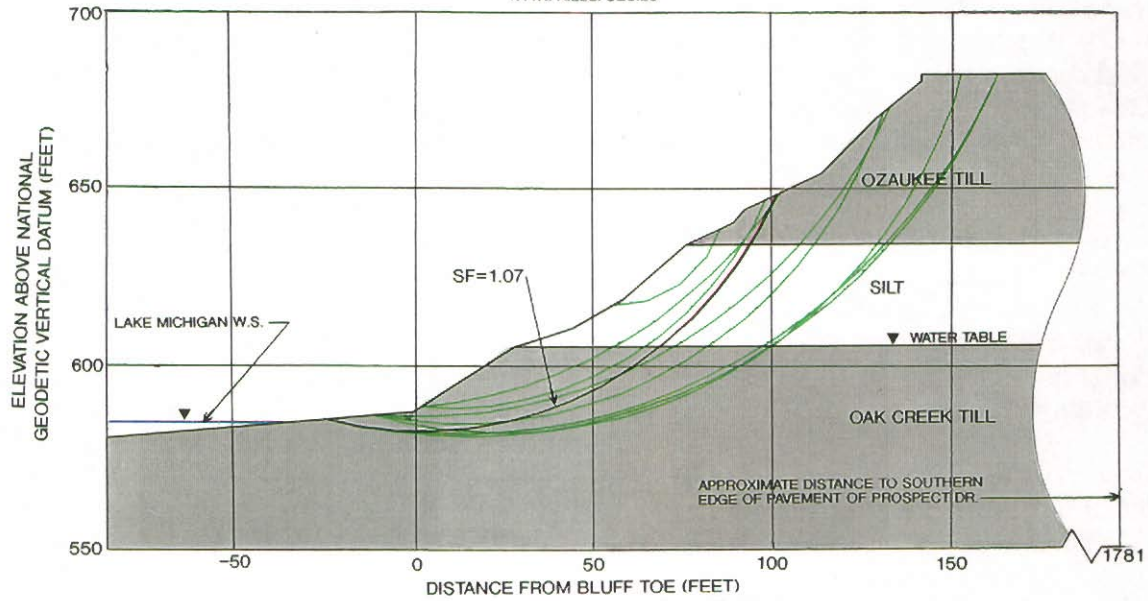
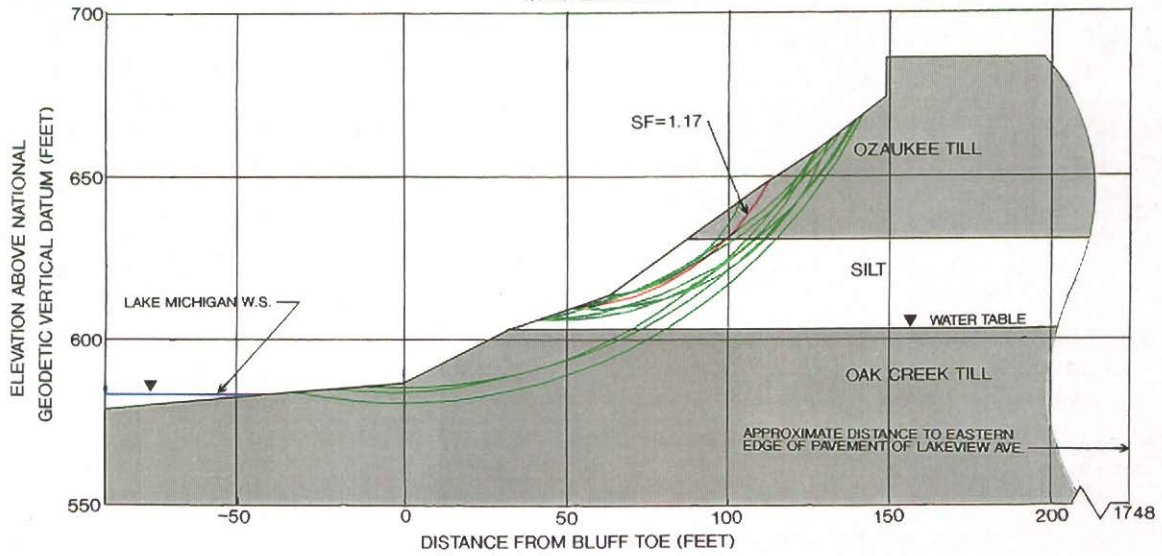
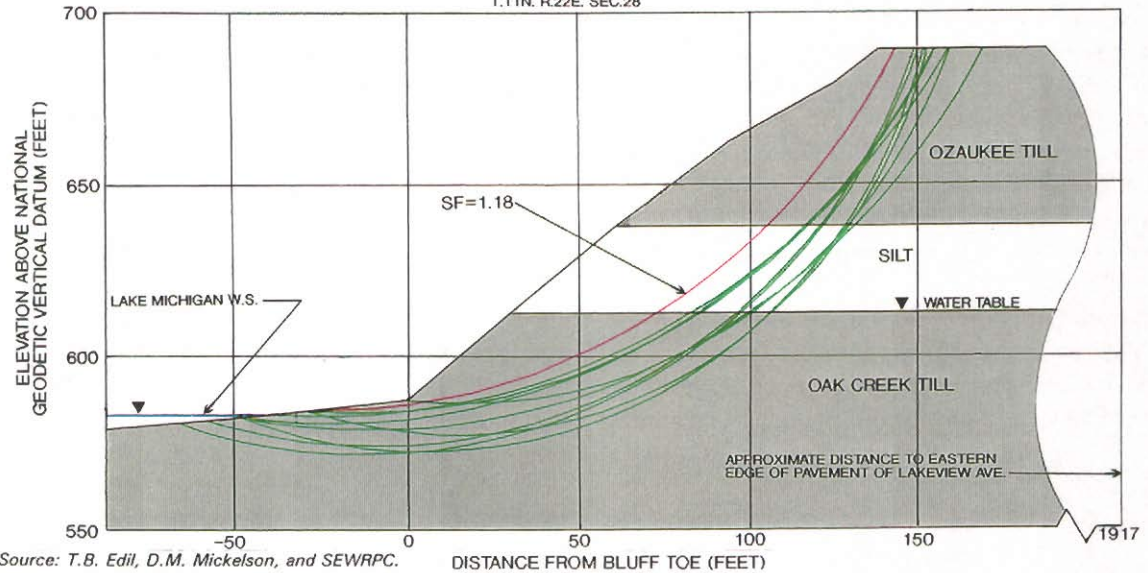
Erosion Zone 28b extends from the northern edge of the City of Port Washington Wastewater Treatment Plant north about 0.08 mile, as shown on Map 81. This zone had about a 50-foot-wide beach fronting a low lake terrace and a bluff with a height of up to 100 feet. In this zone, the bluff was located well behind the terrace and was set well back from the shoreline. The 1995 field observations indicated that the bluff, which was less than 50 percent vegetated, was actively eroding and appeared to have undergone several large failures in the last 20 years. The bluff slope was reported as vegetation-free with the exception of slide masses near the bottom of the bluff slope.

In 1995, three bluff profile field surveys were made within Zone 28b by occupying sites for which field surveys were conducted in 1980. The stability of the bluff in Erosion Zone 28b was characterized by Profile Nos. 15-1 through 15-3. Results of the slope stability analysis, shown in Figure 85, indicated that the bluff was marginally stable, with a safety factor of 1.07 at Profile No. 15-1, and stable, with safety factors of 1.17 at Profile No. 15-2 and 1.18 at Profile No. 15-3 with respect to rotational failures, based upon the deterministic bluff stability analysis. However, 1995 field observations indicated that translational failures may occur. The 1980 study did not report a specific safety factor for these three profile sites.

In 1995, the beach within Zone 28b was about 50 feet wide and beach materials were noted to be sand and gravel. In the 1977 study, the beach width was reported to be between five and 20 feet, and the beach material was reported to be sand. At Profile No. 15-2 the near-shore lakebed depth of five feet was reached at 65 feet offshore. No measurements or observations were made of the nearshore lakebed depth or material within this zone in 1995 or in 1976.

Although Zone 28b was considered stable in 1995, the bluff in this zone has undergone several large failures and remains a threat to the park roads and parking areas on the bluff top. Unless some type of shore protection is provided, Erosion Zone 28b will continue to erode at a moderately high rate. Continued erosion may eventually require rerouting of some of the streets.

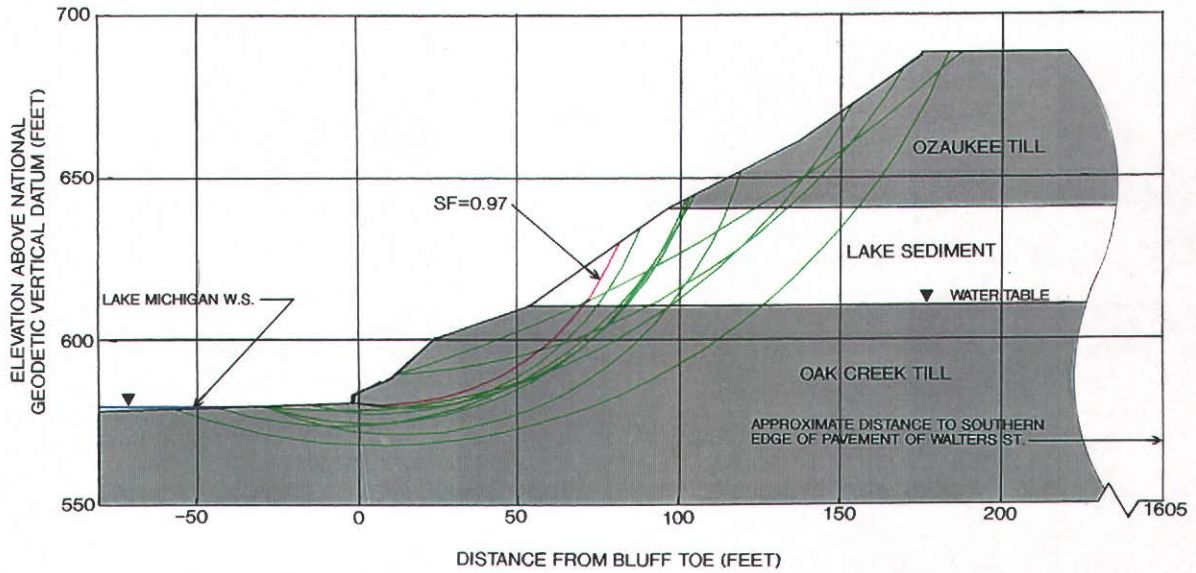
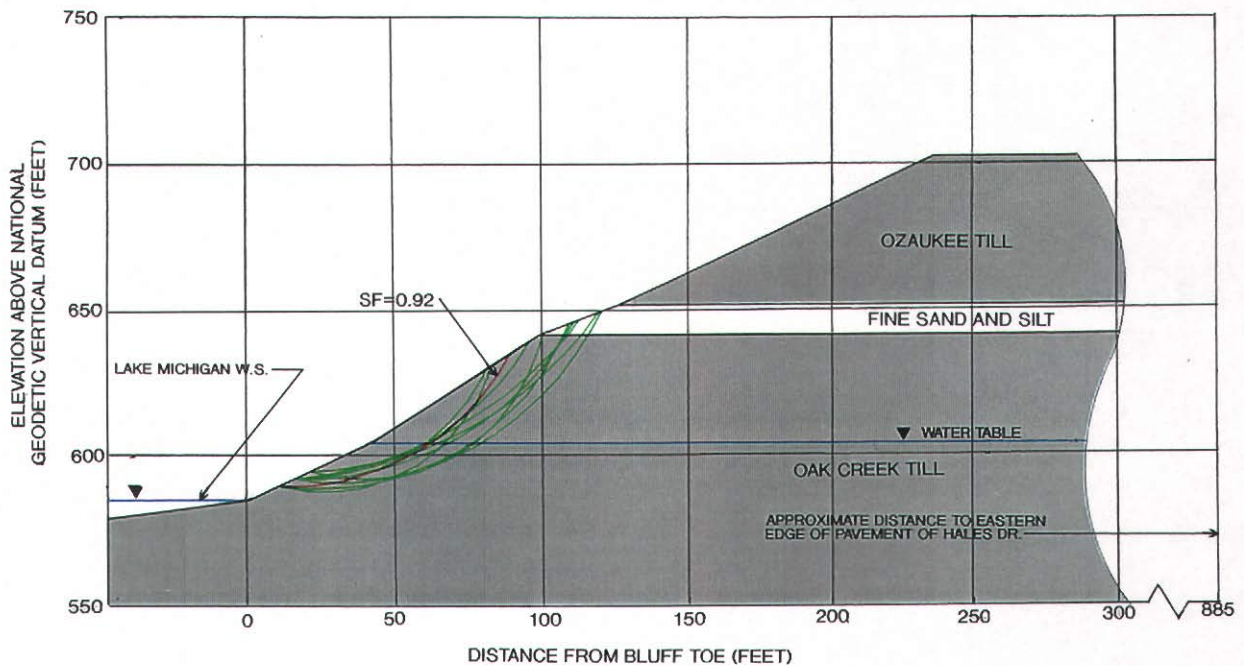
results indicated a safety factor of less than 1.0 for 18, or 72 percent, of the 25 critical conditions, as represented by the set of most critical conditions determined in each of the 25 analyses considered. In addition, a safety factor of less than 1.0 was determined for 101, or 40.4 percent, of the 250 conditions analyzed. At Profile No. 15-5, the probabilistic bluff stability analysis resulted in a range of safety factors from 0.73 to 1.33 for the 250 conditions considered. The analytical results indicated a safety factor of less than 1.0 for 12, or 48 percent, of the 25 critical conditions, as represented by the set of most critical conditions determined in each of the 25 analyses considered. In addition, a safety factor of less than 1.0 was determined for 87, or 34.8 percent, of the 250 conditions analyzed. Given the analytical results and the 1995 field observations, the bluffs were considered marginally stable with respect to both rotational and translational failures. The 1977 study reported a bluff safety factor of 1.21 at Profile No. 15-4. The 1977 study did not report a bluff safety factor at Profile No. 15-5.

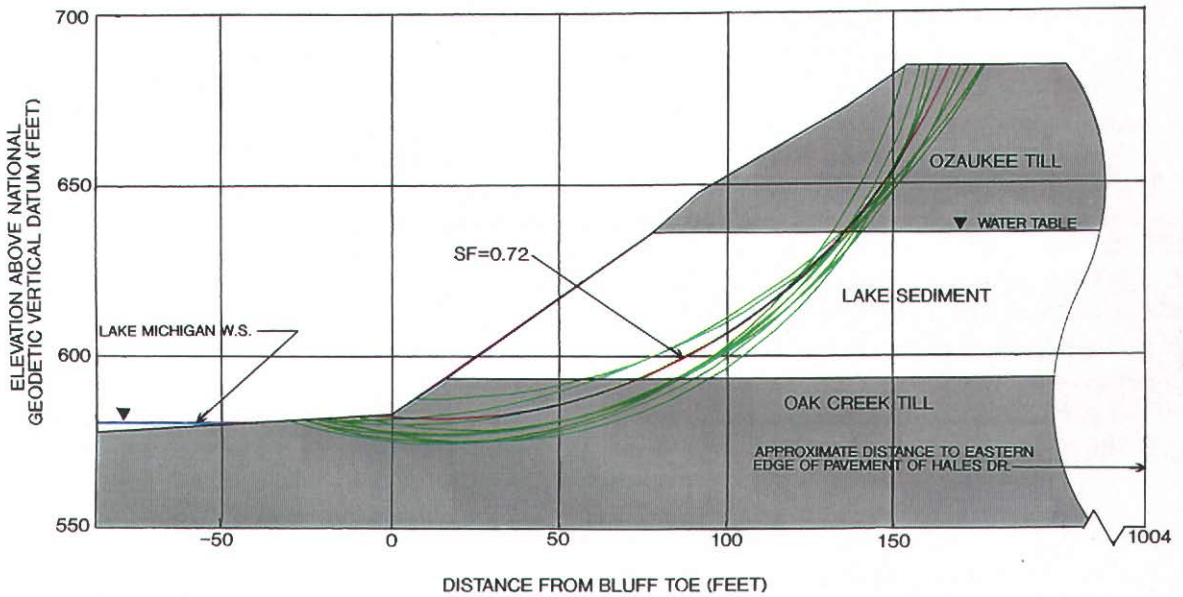
PROFILE 15-6
T.11N. R.22E. SEC.22

Erosion Zone 22a extends from where Noridge Trail ends north about 0.35 mile, as shown on Map 82. This zone had a 50-foot-wide beach fronting a low terrace. The bluff in this zone had a height of about 100 feet. The 1995 field observations indicated that signs of translational failures were present and noted that the bluff was 50 to 80 percent vegetated with shrubs and trees. Bluff failure in this zone seemed to be a result of shallow slides.

In 1995, one bluff profile field survey was made within Zone 22b by occupying a site for which a field survey was conducted in 1976. The stability of the bluff in Erosion Zone 28a was characterized by Profile No. 15-6. Results of the slope stability analysis, shown in Figure 87, indicated that the bluff was unstable with respect to both rotational and translational failures, with a safety factor of 0.72, based upon the deterministic bluff stability analysis. The 1977 study reported a safety factor of 0.61 for this site.

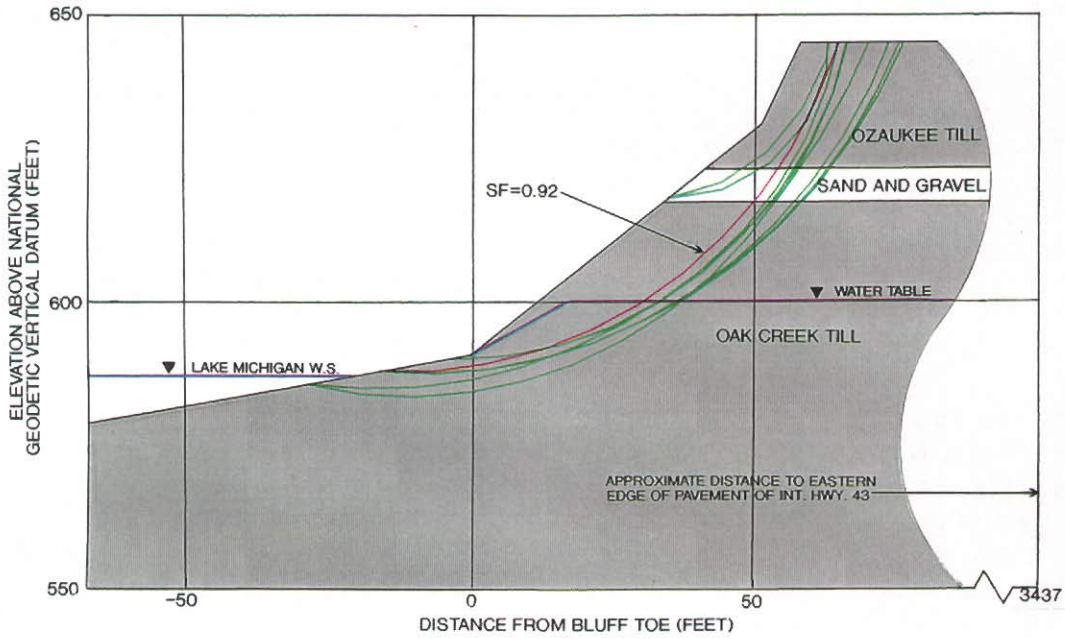
PROFILE 15-12
T.11N. R.22E. SEC.11

ure 90, indicated that the bluff was unstable, with a safety factor of 0.92, based upon the deterministic bluff stability analysis method. Profile No. 15-12 was also analyzed using the probabilistic bluff stability analysis method which resulted in a range of safety factors from 0.67 to 1.22 for the 250 conditions considered. The analytical results indicated a safety factor of less than 1.0 for 19, or 76 percent, of the 25 critical conditions, as represented by the set of most critical conditions determined in each of the 25 analyses considered. In addition, a safety factor of less than 1.0 was determined for 172, or 68.8 percent, of the 250 conditions analyzed. Given the analytical results and the 1995 field observations, the bluffs were considered unstable with respect to both rotational and translational failures. The 1977 study reported a similar bluff safety factor of 0.91.
